Fire Services Report Feb 19, 2025

707 Queens Avenue

Subject: 707 Queens Avenue Structure Demolition Request

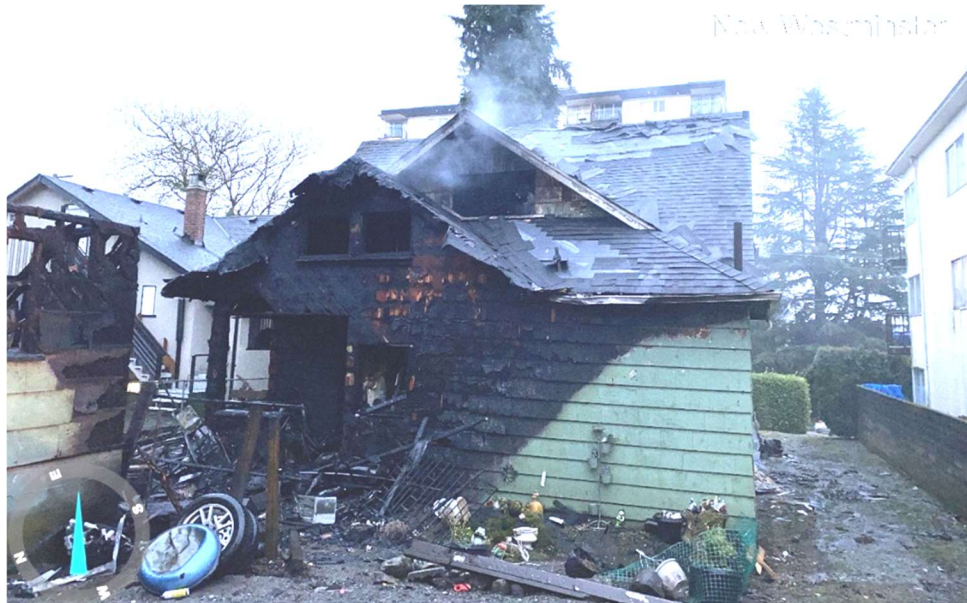
Extensive fire damage was observed to the rear of the house extending to the interior and the roof structure, which was no longer intact. The detached garage was also extensively fire damaged and was eventually demolished to facilitate fire suppression efforts.

Figure 1: Rear of the house located at 707 Queens Avenue.

After the fire incident on January 31, 2025, the house located at 707 Queens Avenue is no longer habitable. The house is structurally compromised with the rear portion of the house partially consumed by the fire and the roof no longer intact. Heavy charring is observed to the framing and flooring of the house with areas that are no longer intact. The garage was demolished as a part of the fire suppression efforts but the debris, including the excessive amount of combustible contents that was in the garage, remains on site.

The fire damaged structure located at 707 Queens Avenue is recommended to be demolished as soon as possible to limit the fire and structural hazards that is currently present.

The fire incident that occurred at 707 Queens Avenue on January 31, 2025 resulted in a fire damaged structure and a demolished garage on site that are creating an undue fire and life safety hazard. We recommend that the remaining house be demolished and the debris be removed as soon as possible.
