# New Westminster Community Heritage Commission

349 AND 351 CUMBERLAND ST

## **ENGINEERING PROPERTY / BUILDING CONDITION ASSESSMENT**

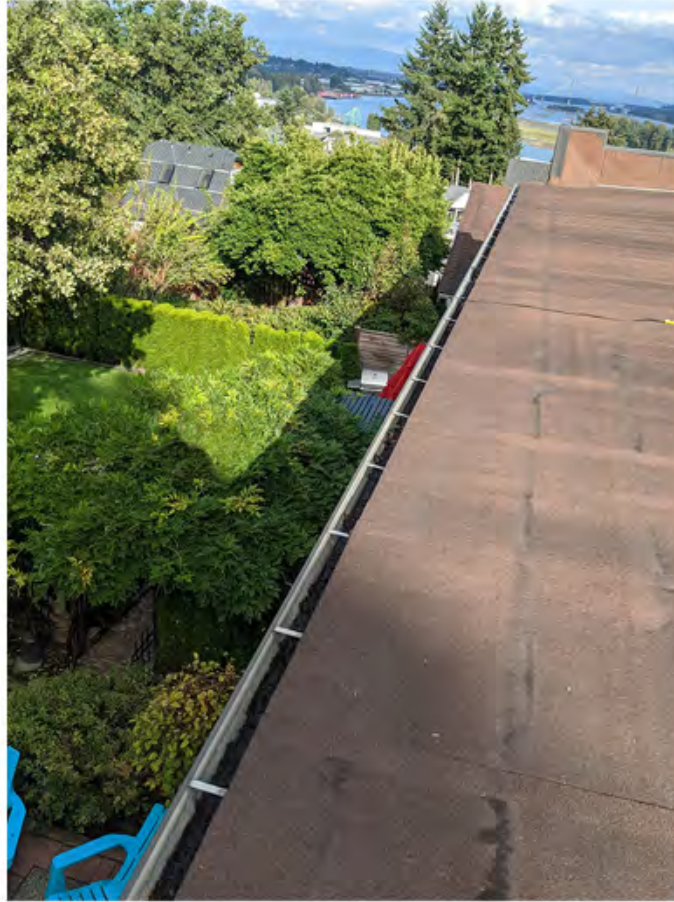
view looking east along north eavestrough.jpg

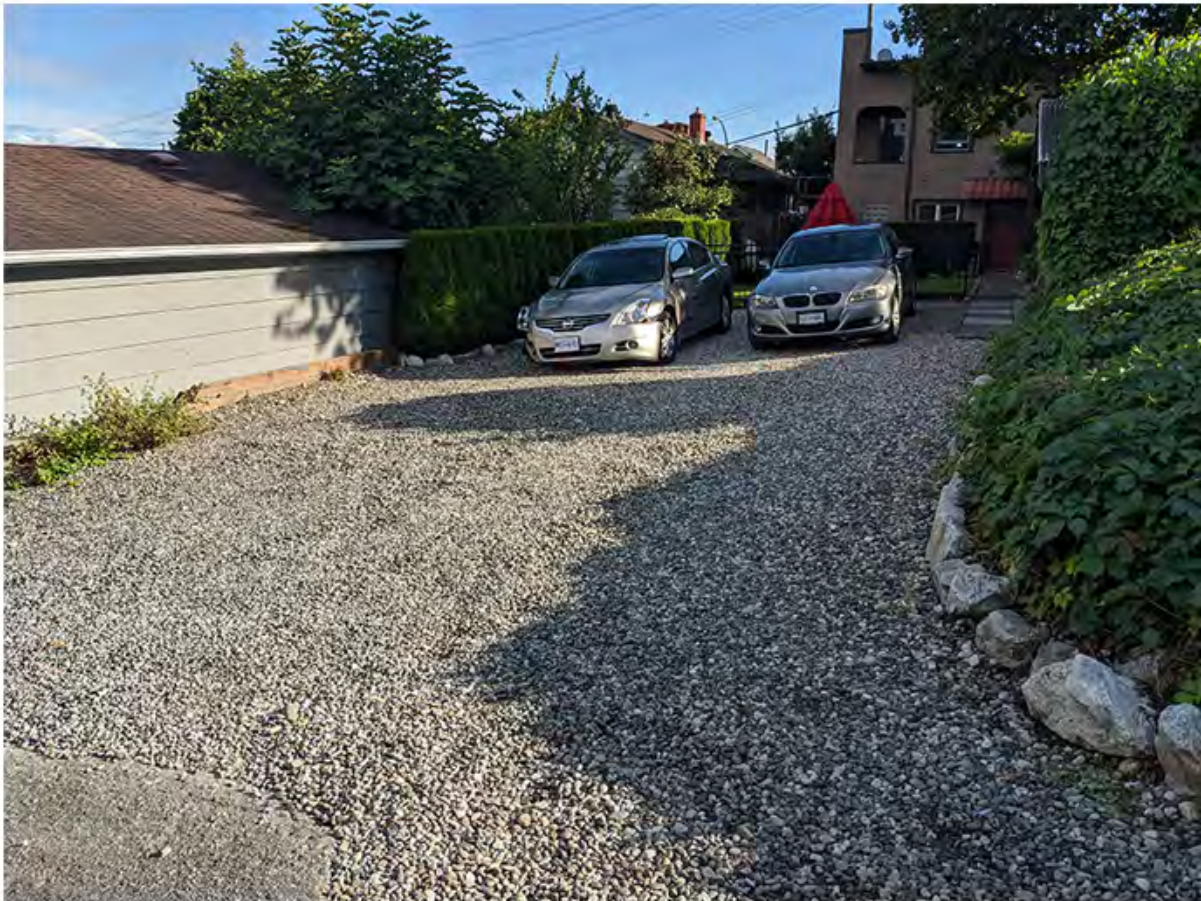
unit 349 - gravel parking pad.jpg

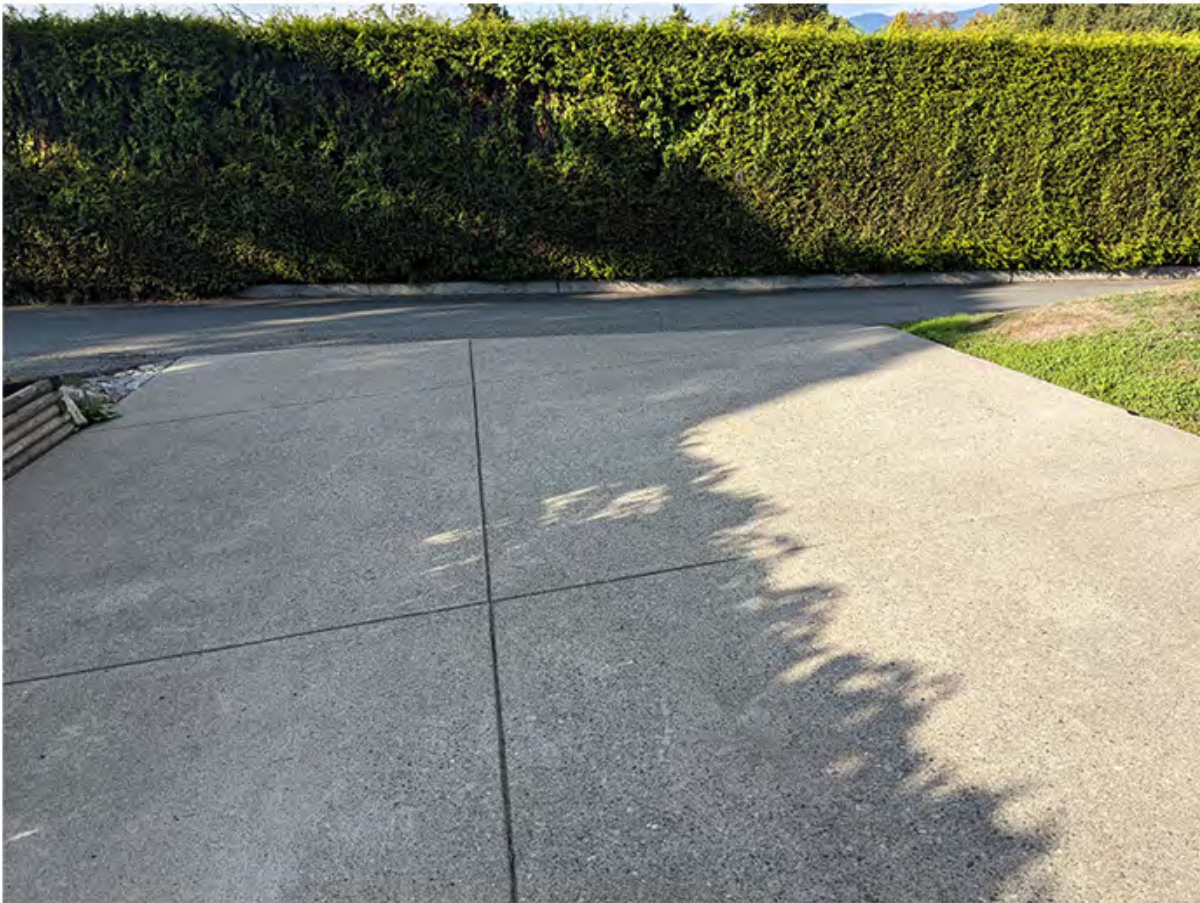
unit 351 - concrete parking pad on north side.jpg

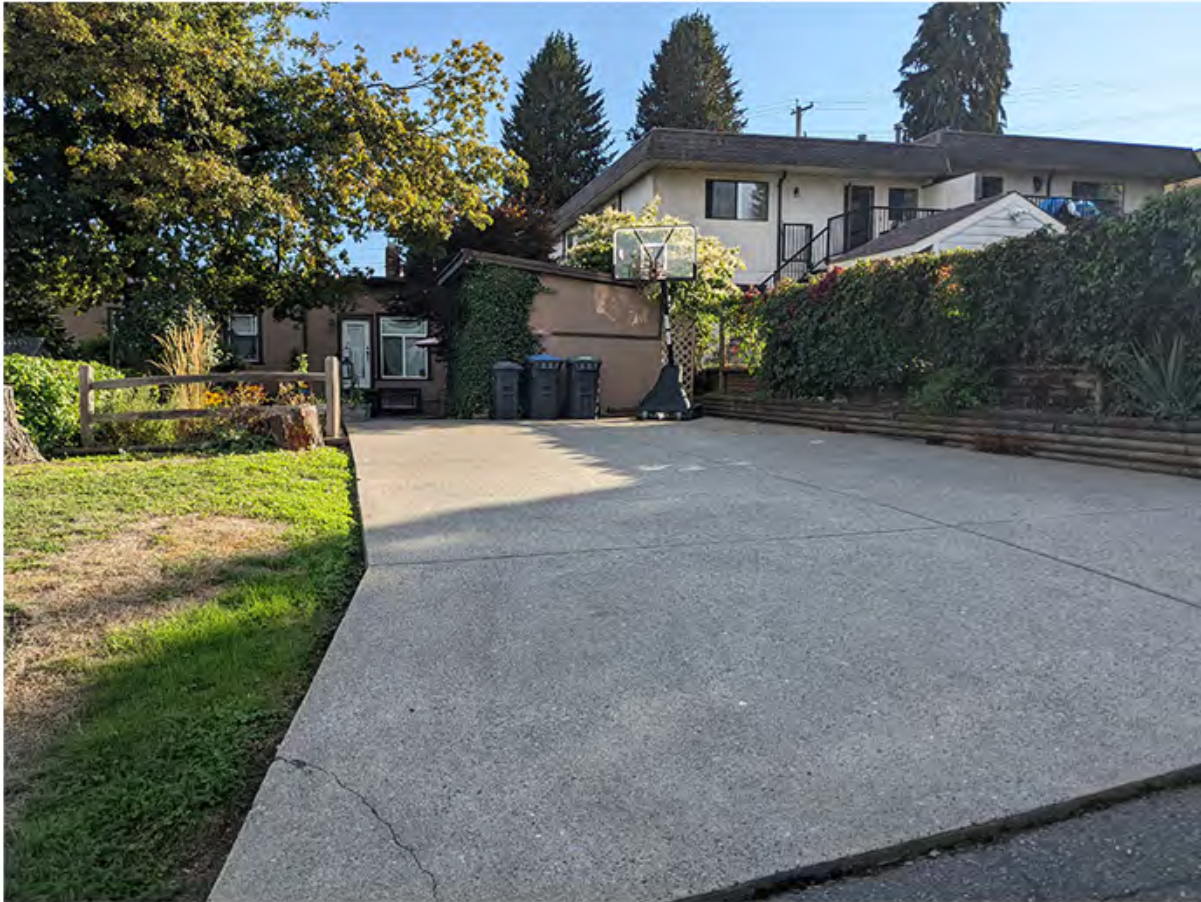
unit 351 - view looking south at parking pad shed and building.jpg

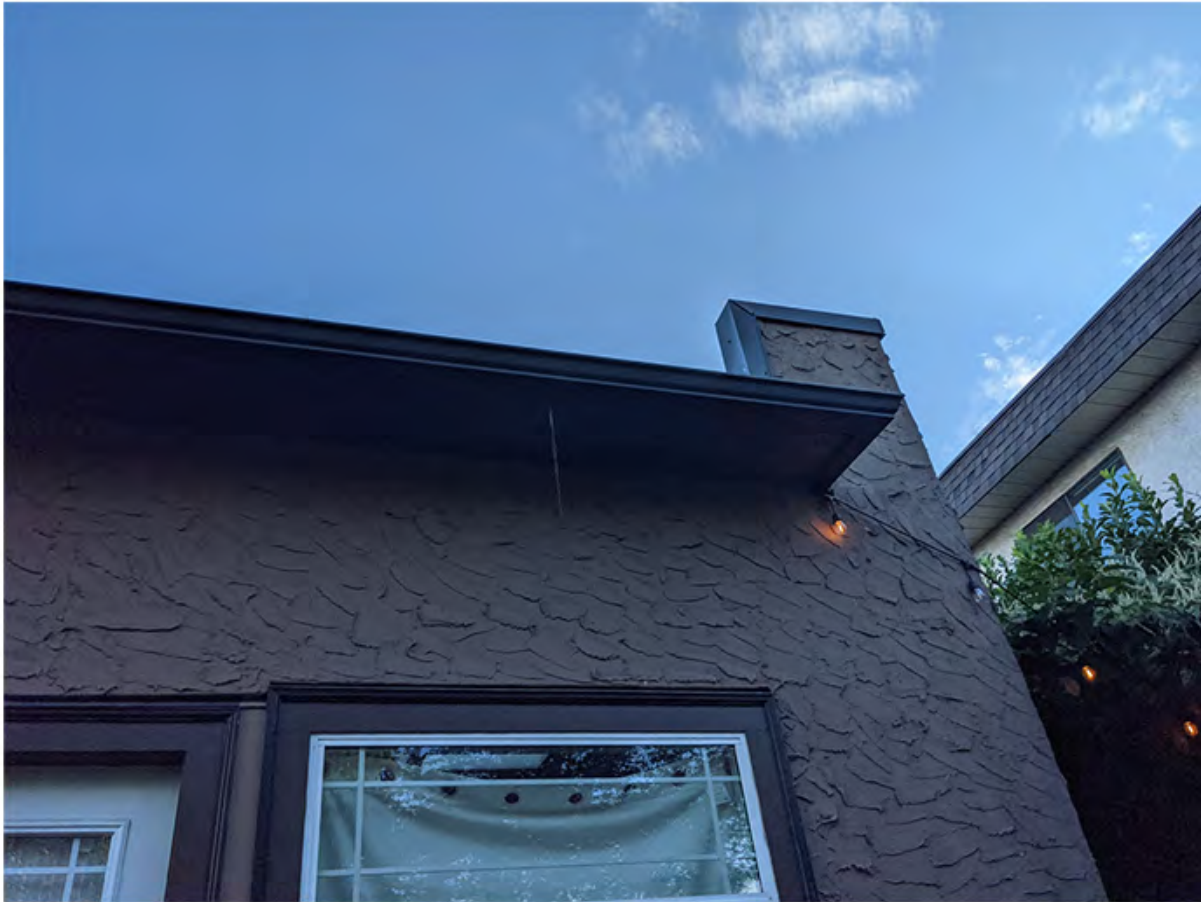
unit 351 - north wall upper level on west side.jpg

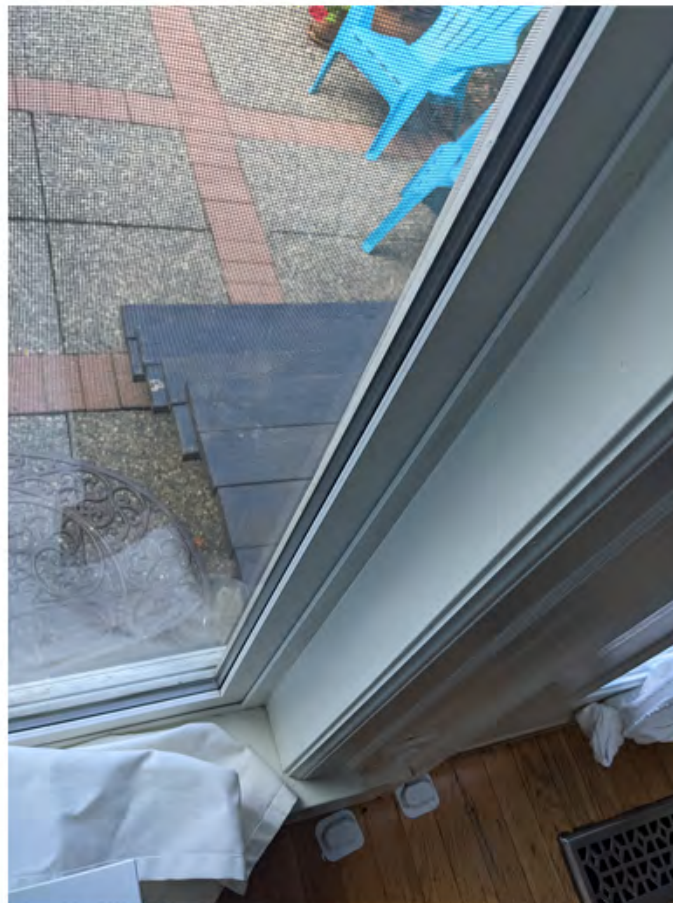
unit 351 - PVC framed window in kitchen on north wall.jpg

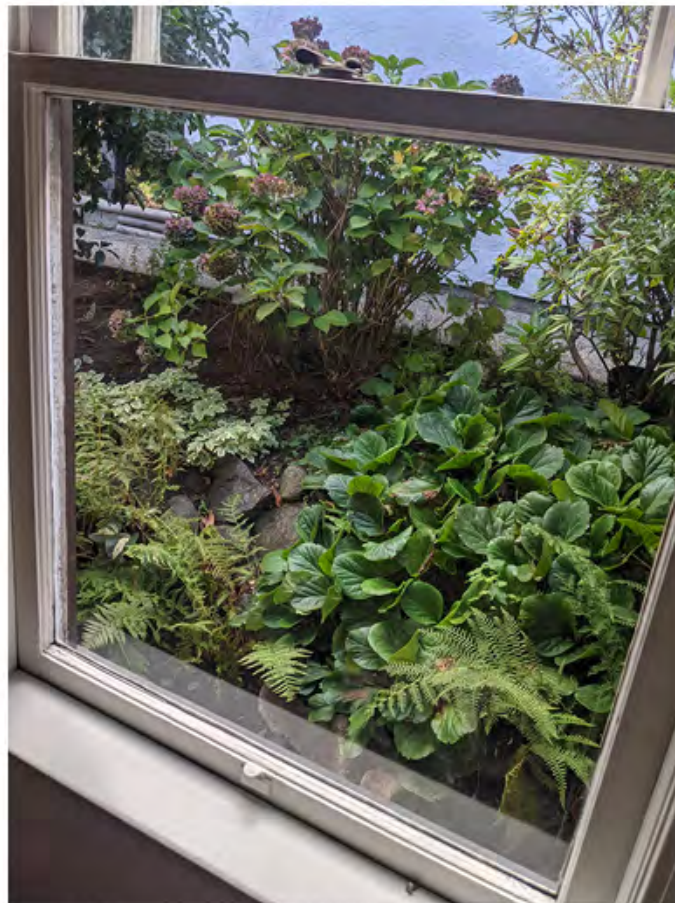
unit 351 - wood framed window in sitting area on west wall.jpg

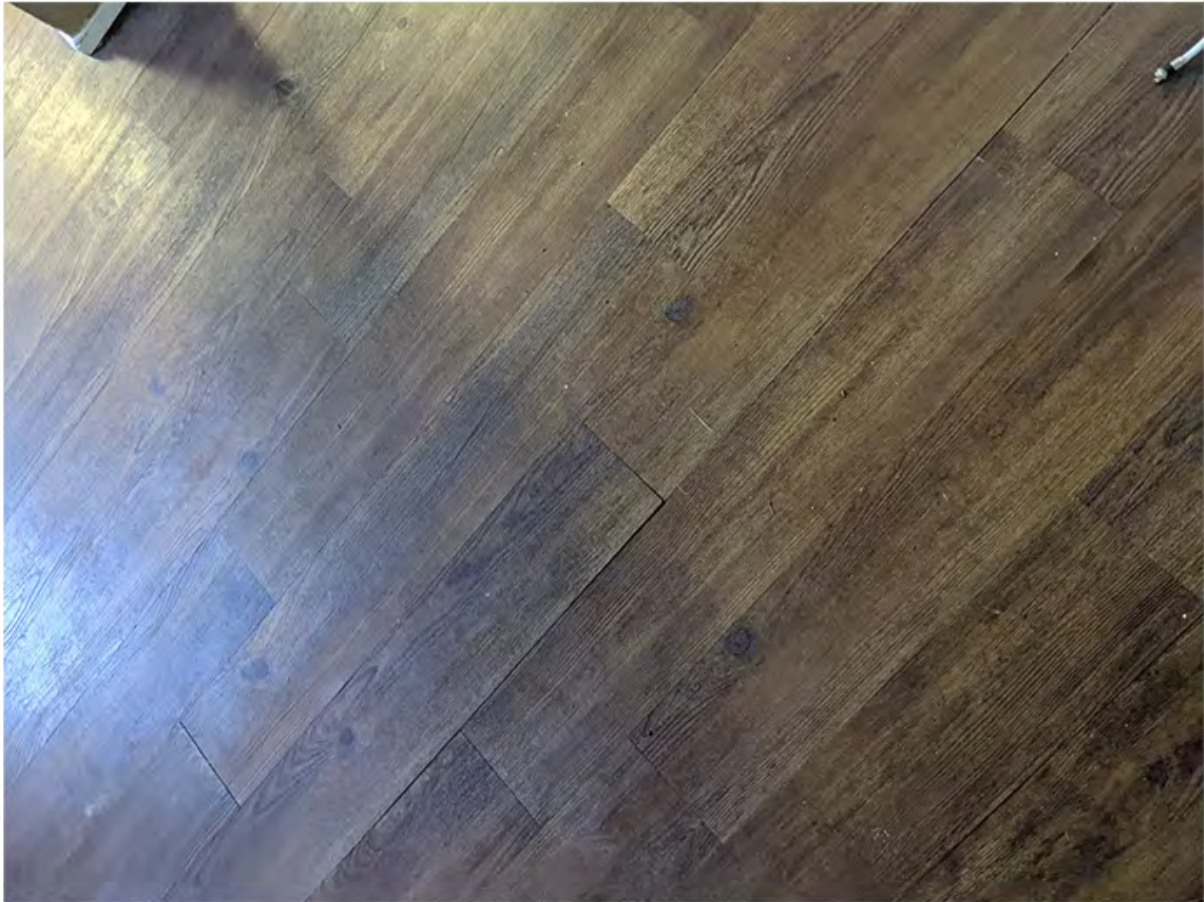
unit 349 - lower level flooring.jpg

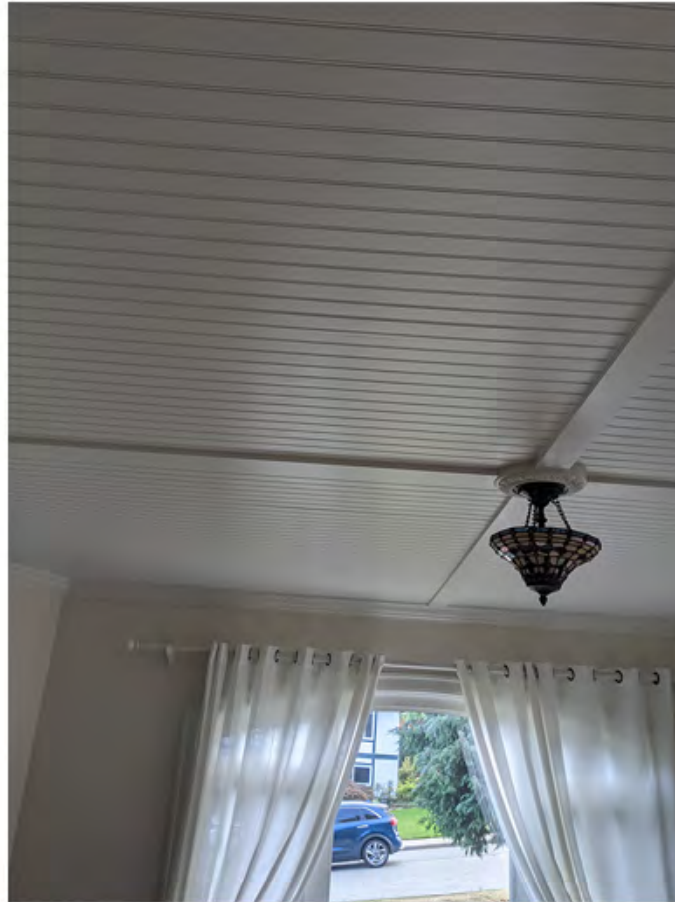
unit 351 - ceiling in sitting room.jpg

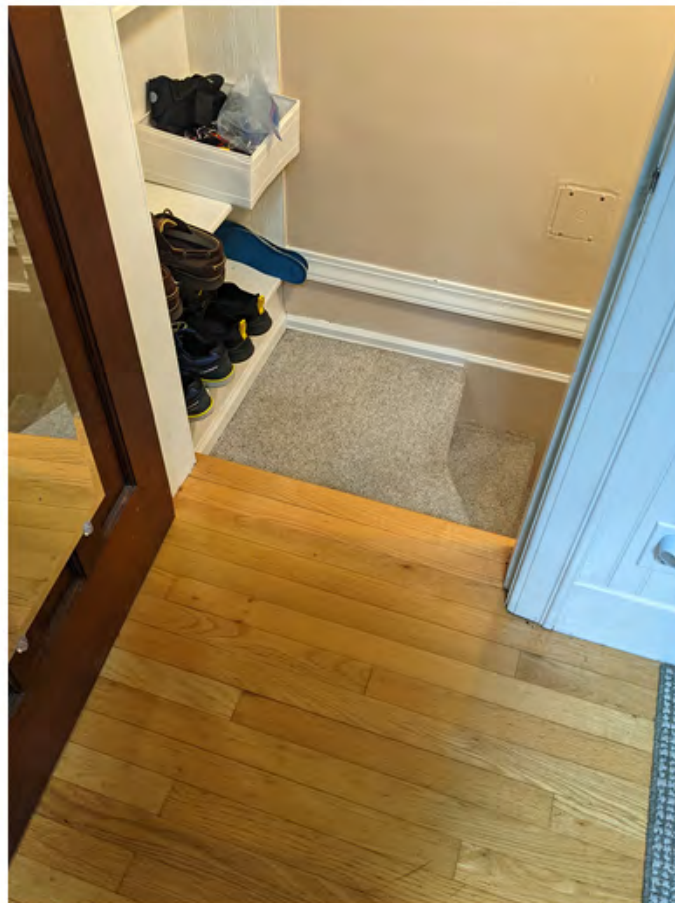
unit 351 - flooring in upper level and stairwell to lower level.jpg

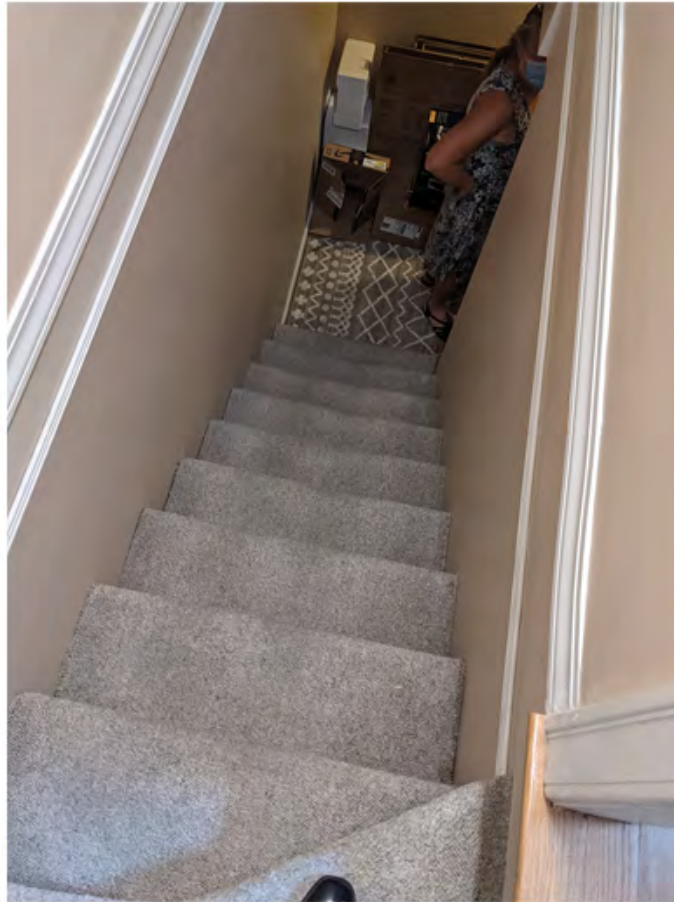
unit 351 - lower level stairway.jpg

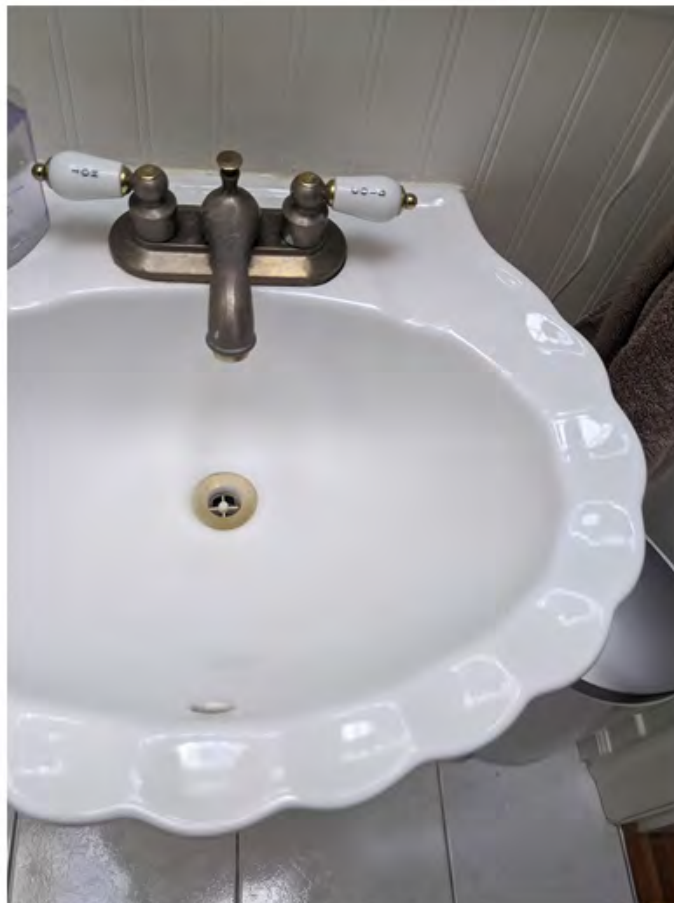
unit 351 - main level sink.jpg

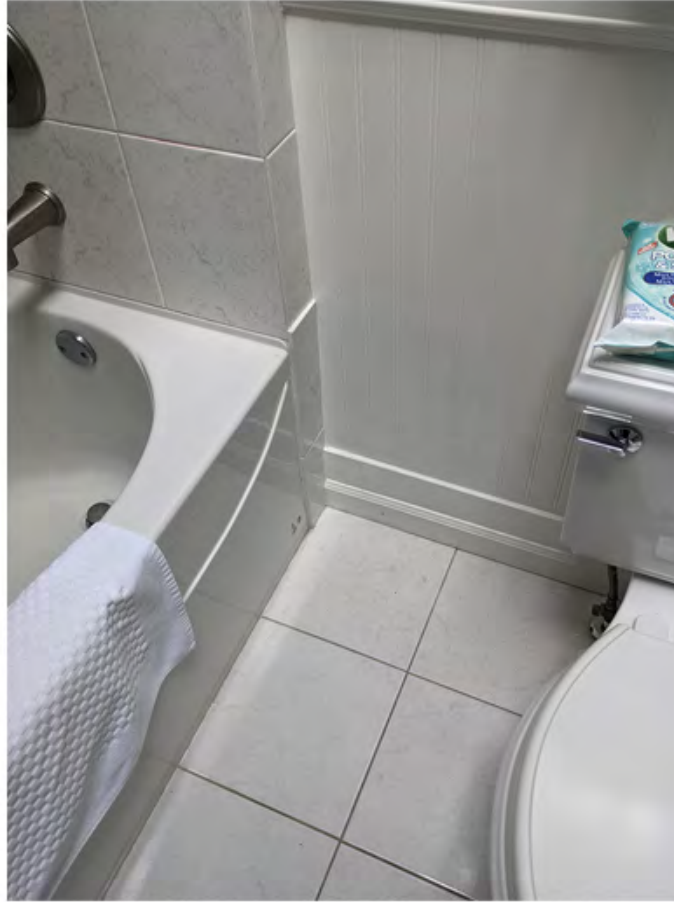
unit 351 - WC flooring wall and surround materials.jpg

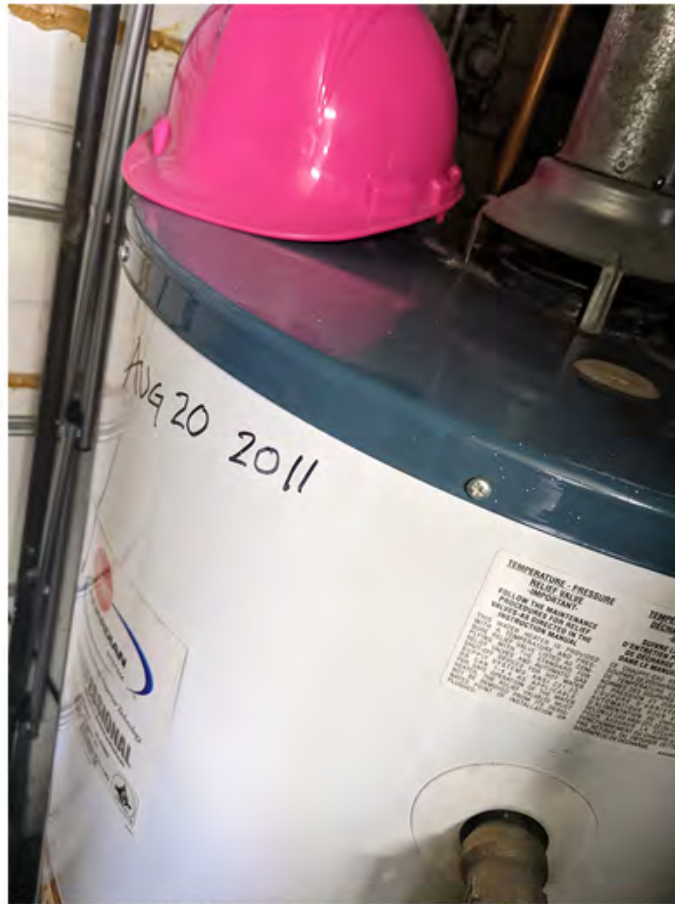
unit 349 - water heater installed in 2011.jpg

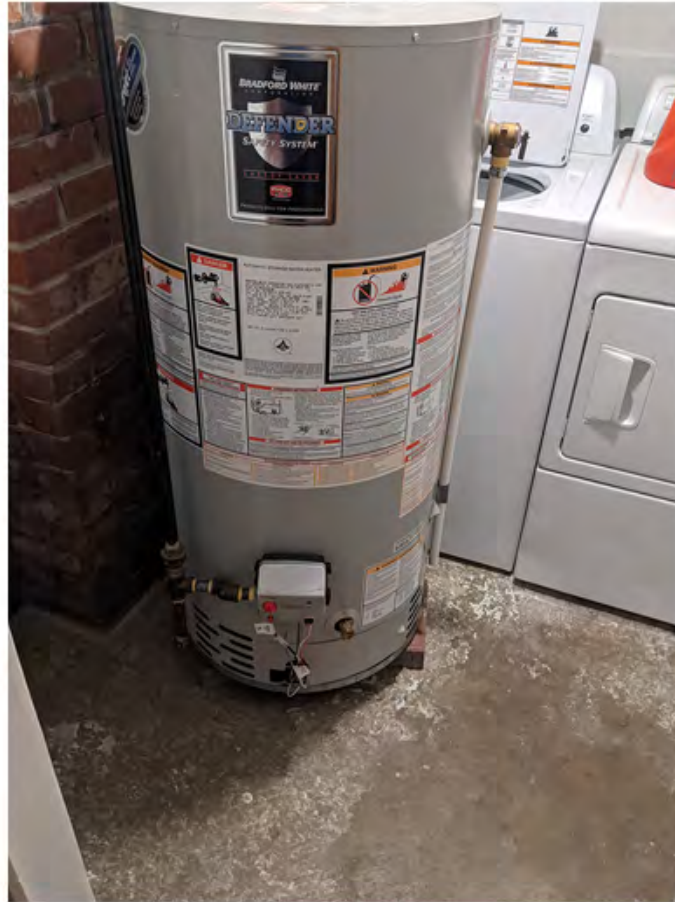
unit 351 - Bradford White HW heater MD 201210.jpg

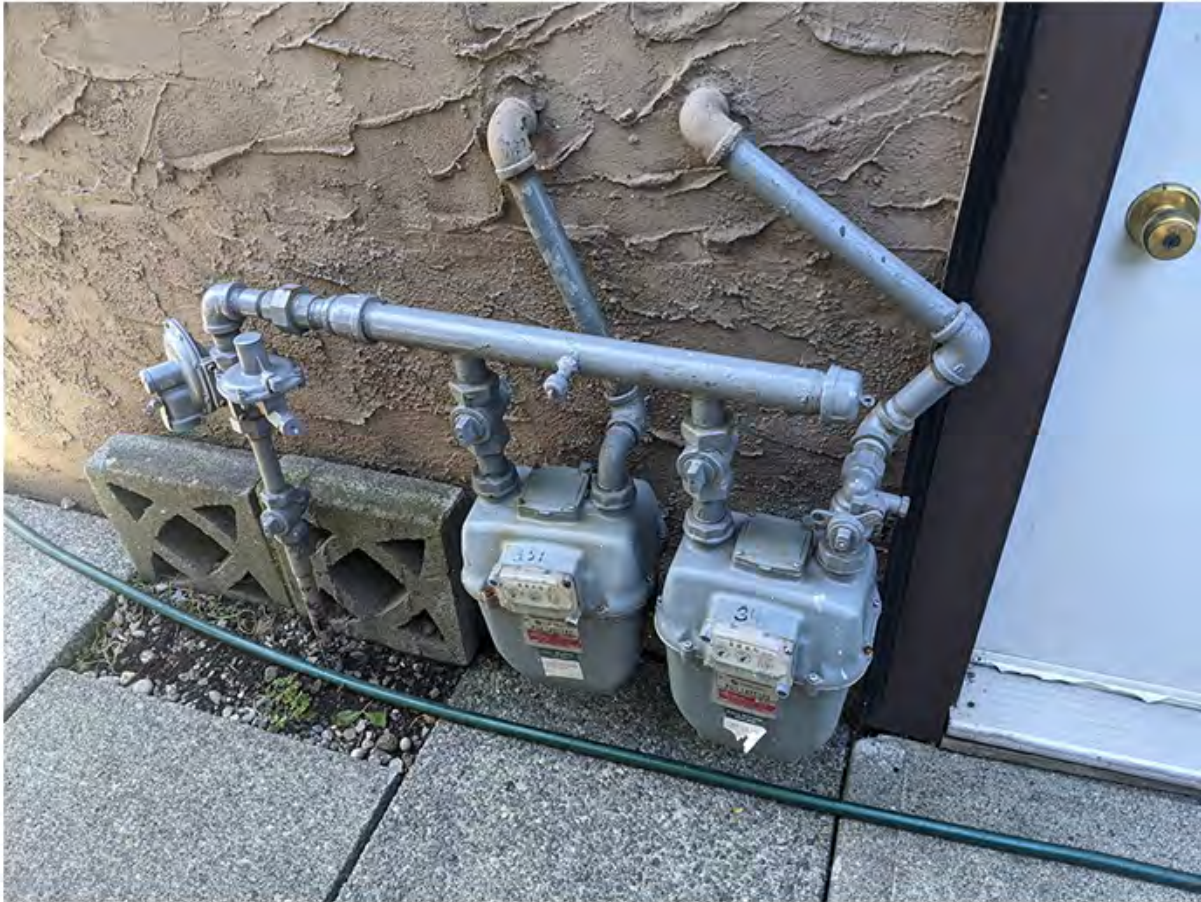
natural gas meters just south of crawl space access door on east wall.jpg

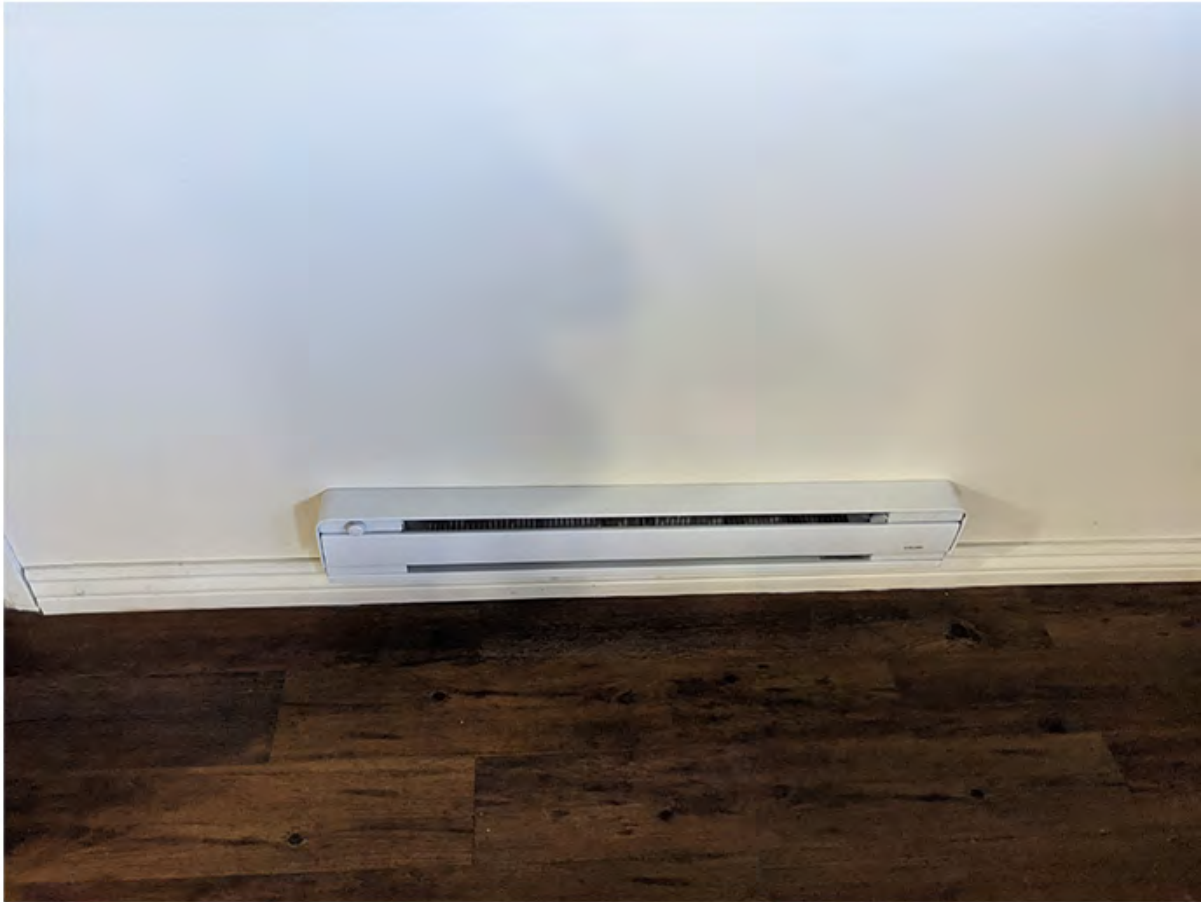
CMG observed two natural gas forced heaters in each unit's lower level.

unit 349 - lower level baseboard heater.jpg

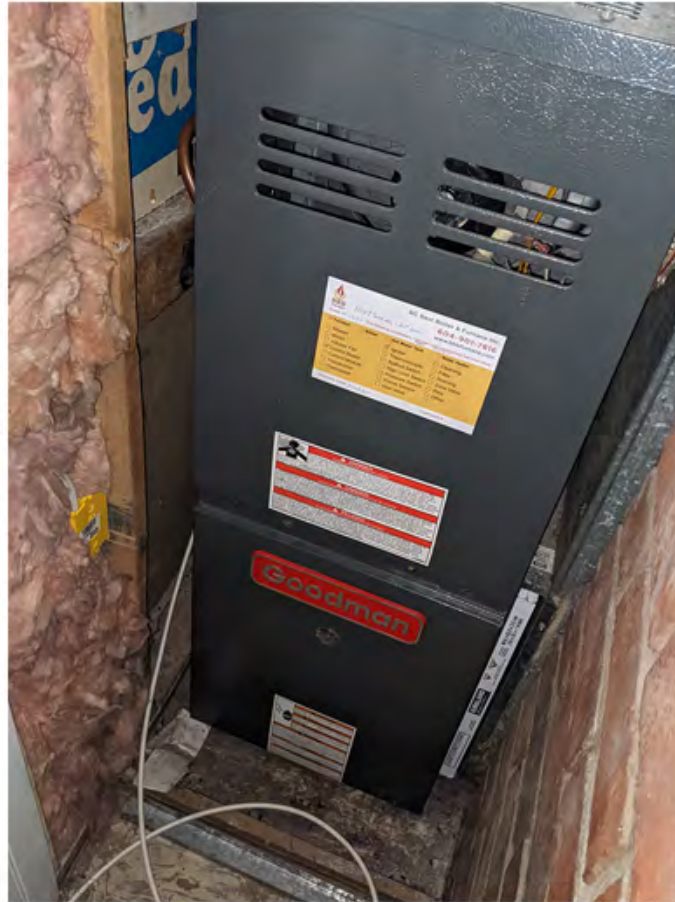
unit 351 - likely high efficiency goodman furnace.jpg

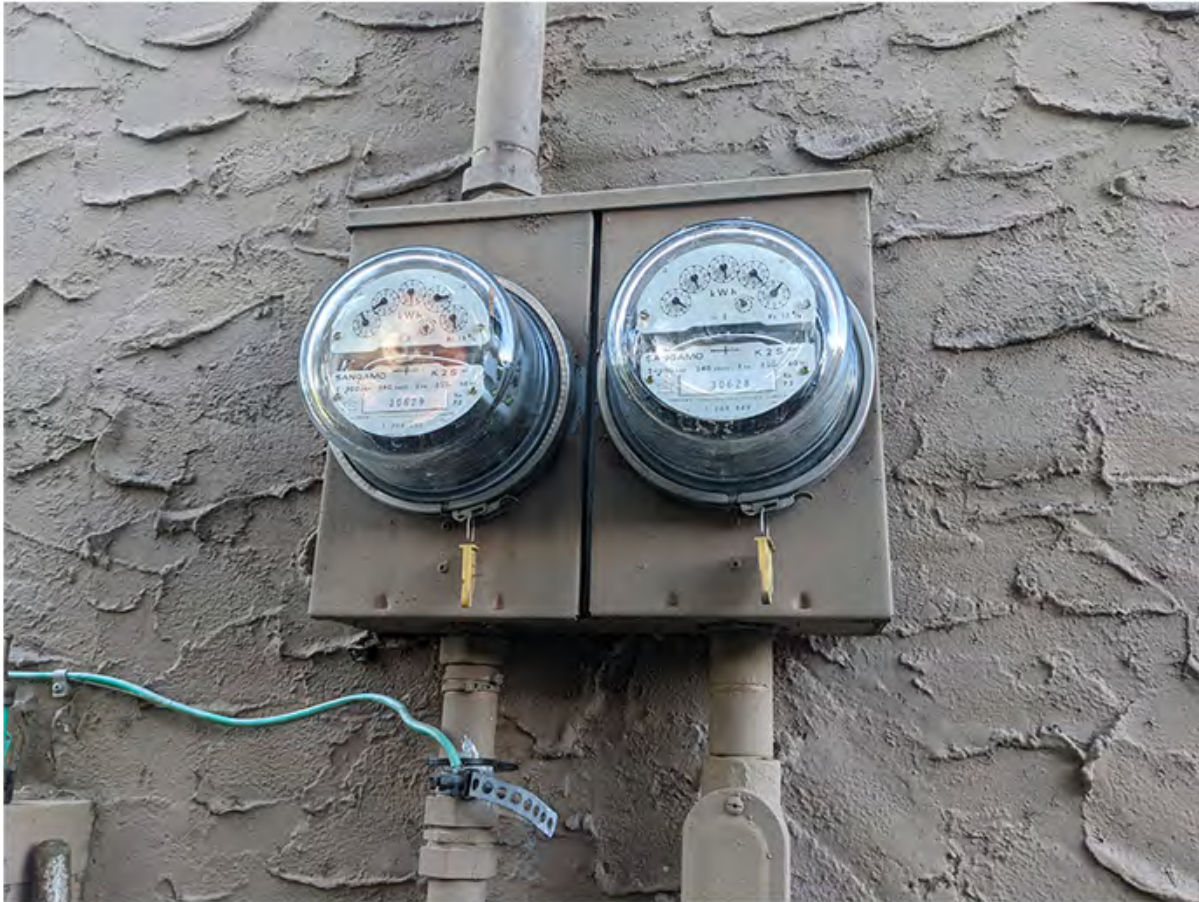
CMG observed overhead wire emanating from a pole across Cumberland St that was attached to the Subject Building on the east side of the South wall. The wire then went into a conduit, around to the east side of the Subject Building, and down to two 240V single phase electrical meters in the lower central section of the east wall.

single phase electrical meters for both units on central east wall.jpg

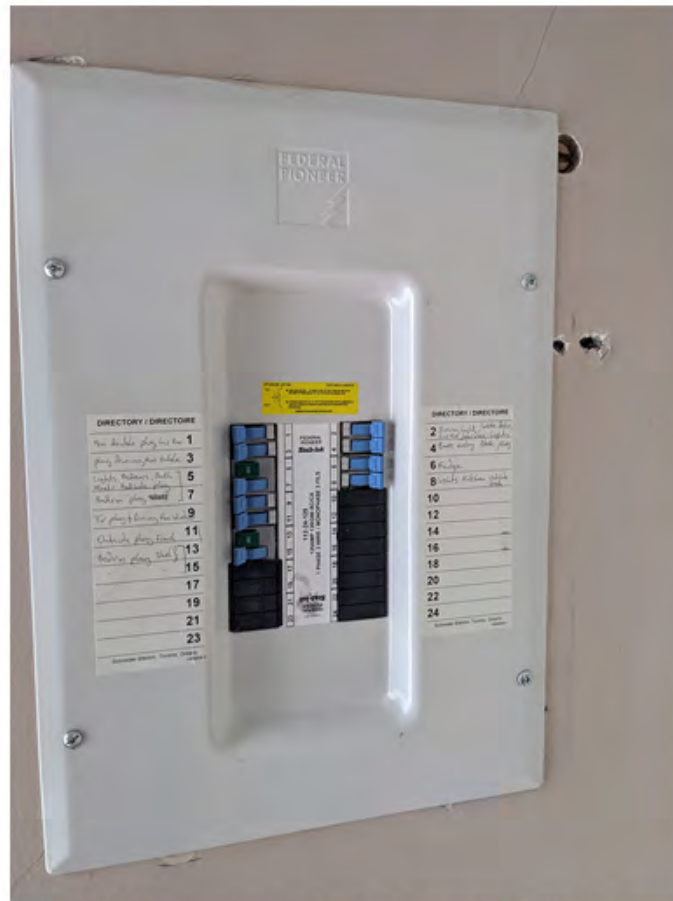
unit 351 - electrical panel west of WC on main level.jpg

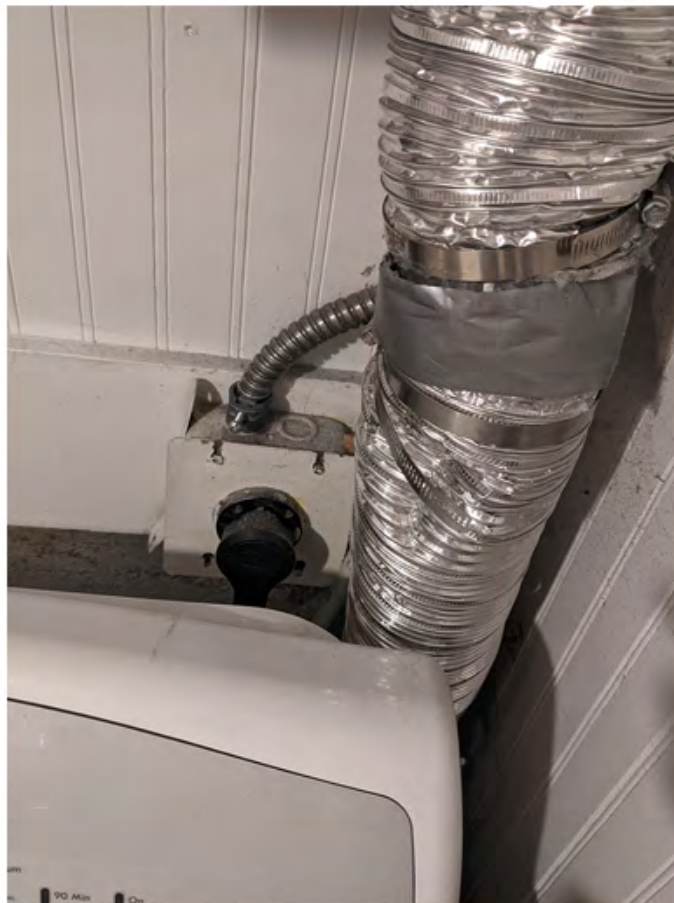
unit 351 electric dryer.jpg
