Attachment H

*Integrated Services Letters from July 2018
to December 2021*

NEW WESTMINSTER

Re: Property known as: 53 Fourth Street, New Westminster, BC
Legal Description: BLOCK 16, NEW WEST DISTRICT, PLAN LMP28797 PARCEL
A AIRSPACE, GROUP 1.

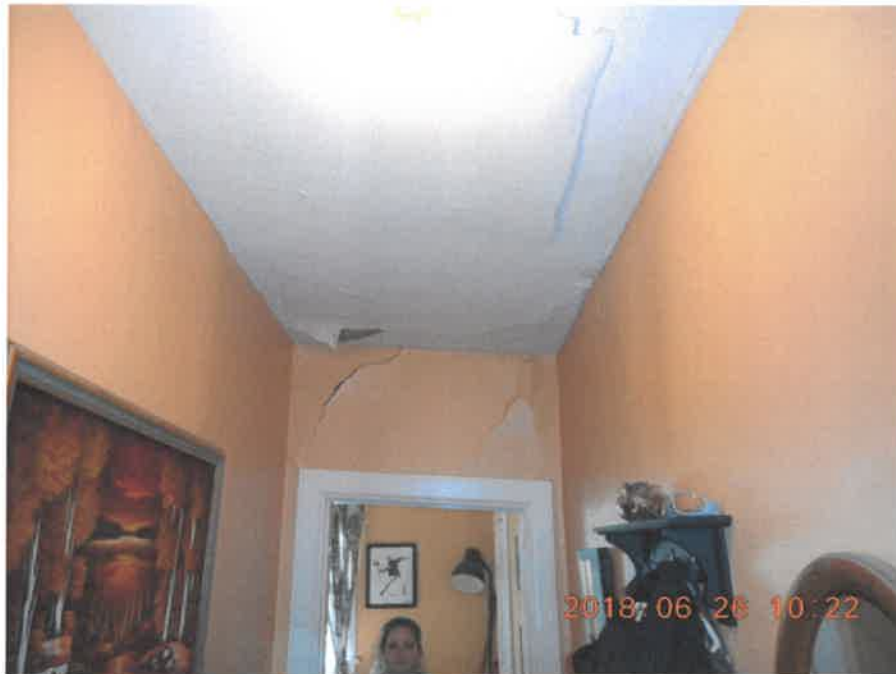
Photo 9: Another view of the suites ceilings near the front entry.

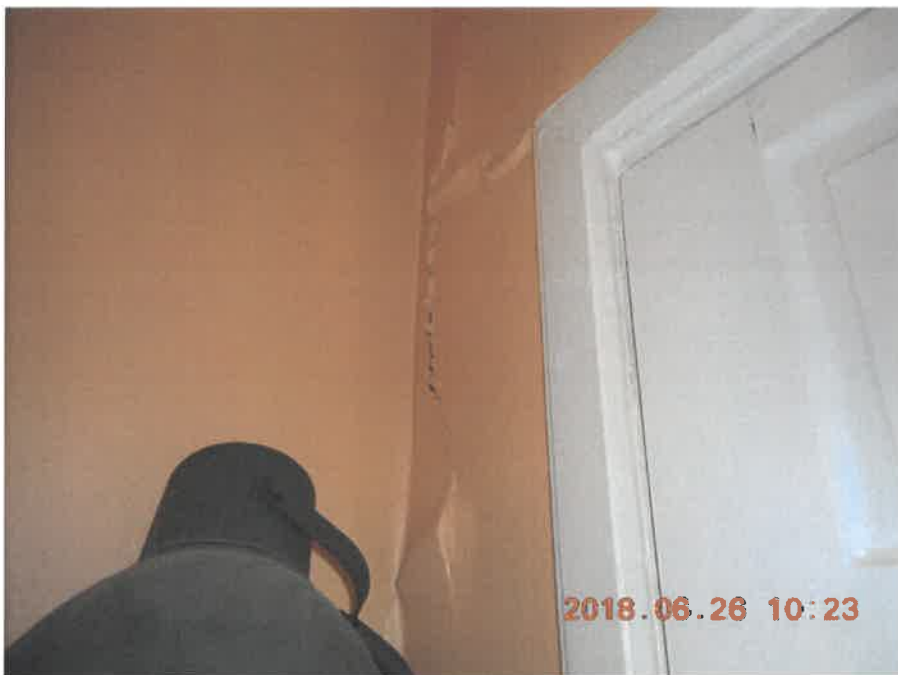
Photo 14: A close up view of the wall near the bedroom door.

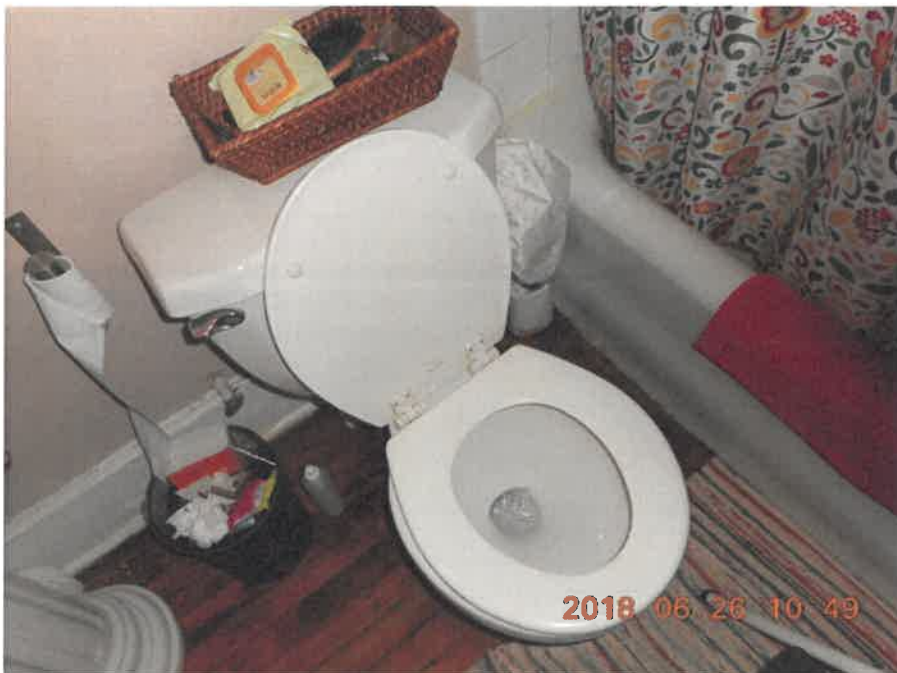
Photo 42: Toilet water running consistently.

- Toilet water is running and requires investigation and repair (see photo #42).
- Mice were reported in this unit and require treatment by a licensed pest control.
- Fridge seal requires replacement.

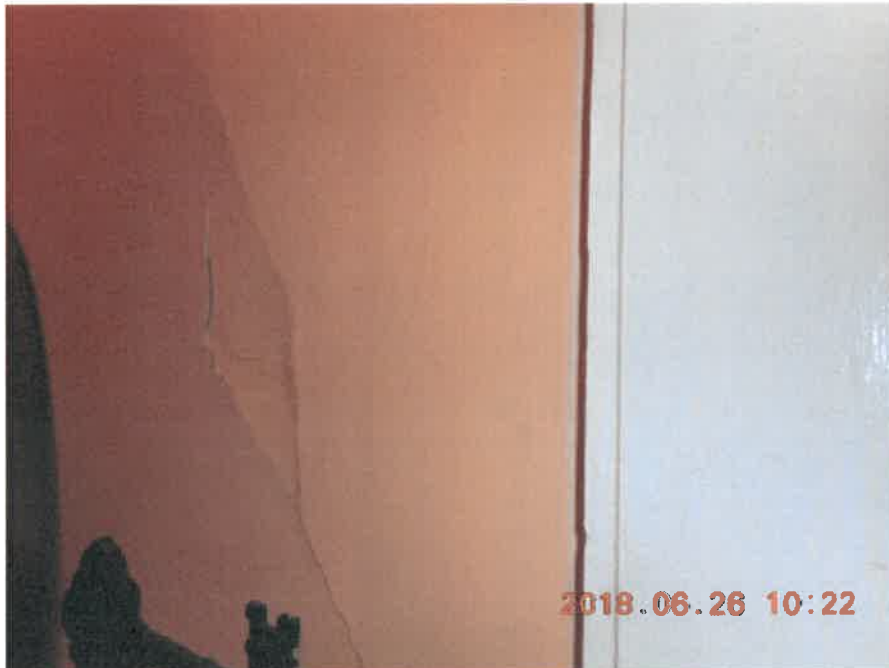
Photo 7: Suite walls have large creeks near the exterior Southwest wall and floor is extremely sloped and appears to be sinking in this corner of the building.

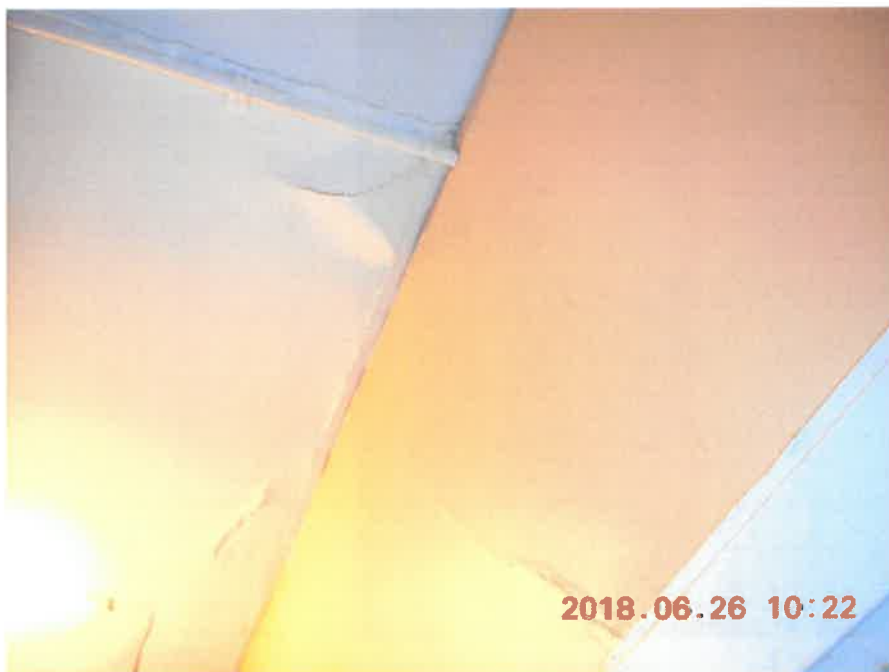
Photo 8: Suite ceiling have large creeks near the exterior Southwest wall and floor is extremely sloped and appears to be sinking in this corner

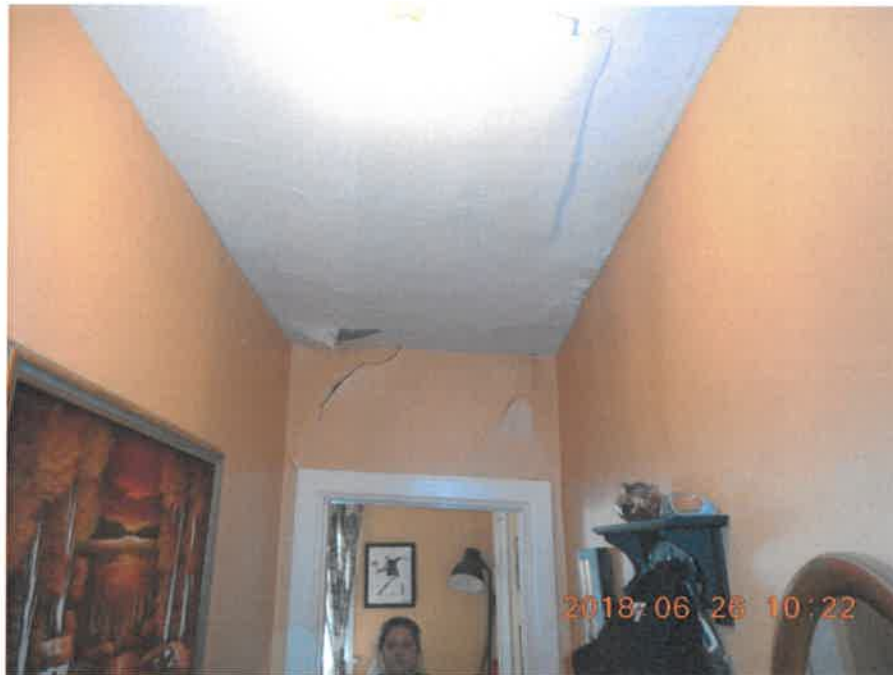
Photo 9: Another view of the suites ceilings near the front entry.

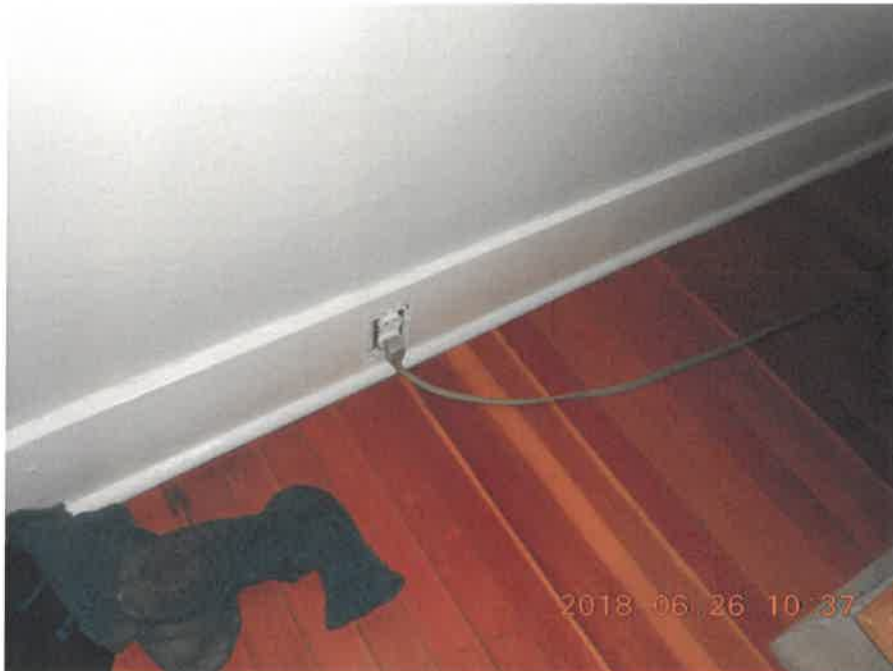
Photo 25: Electrical outlet has no cover plate.

- Living room floor is sloped and requires assessment and repair.
- Light switches and electrical outlets require cover plates (see photo #25).
- Hallway wall is cracked and requires assessment and repair (see photo #26).
- Living room ceiling has a hole and requires repair (see photo #27).

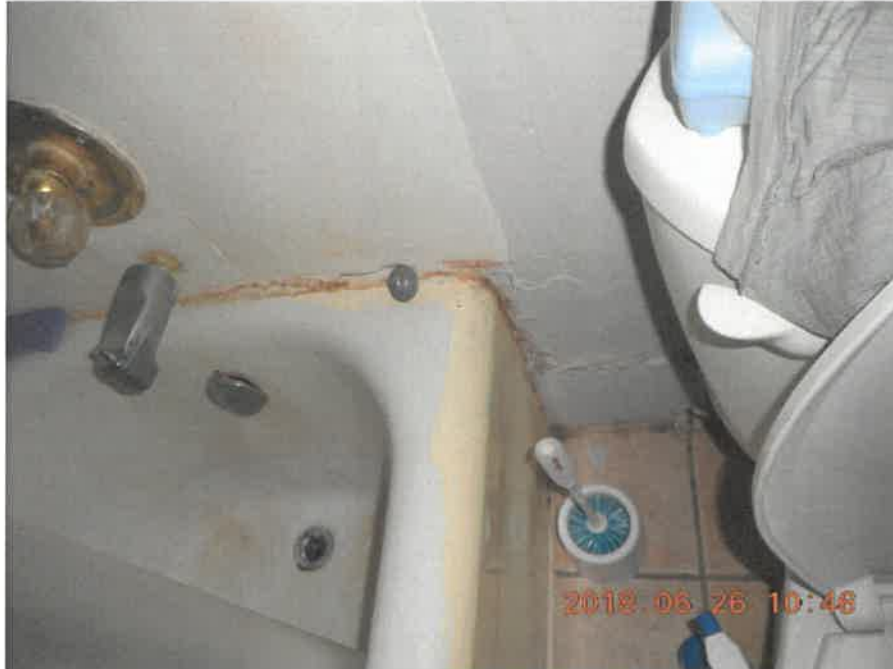
Photo 37: Caulking around the tub, toilet and floor is rotted.

- Caulking around the bathtub and toilet require repair rendering them impervious to moisture to prevent water damage (see photo #37).
- Wall in the living room is cracked and requires assessment and repair (see photo #38).

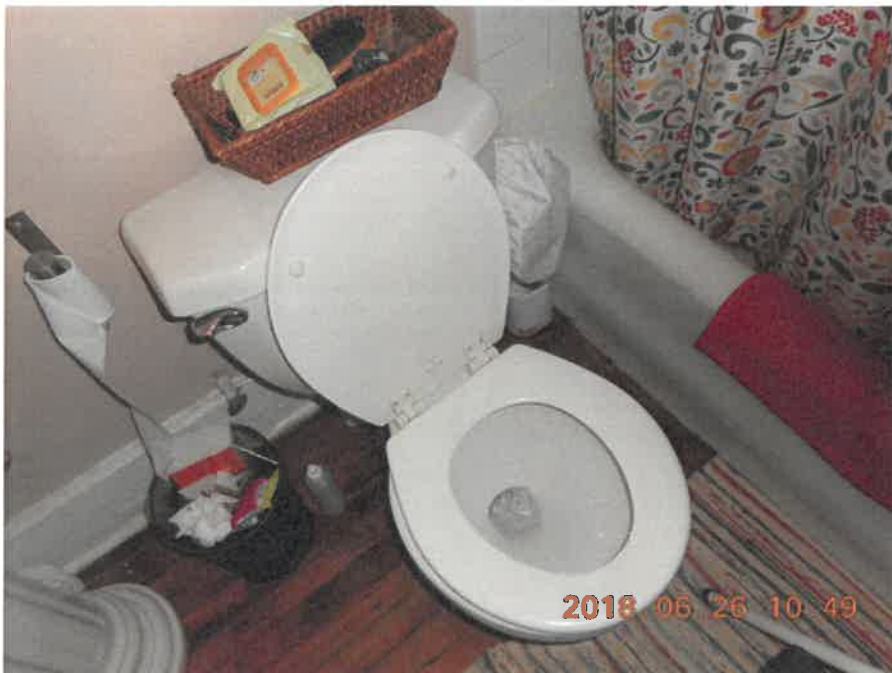
Photo 42: Toilet water running consistently.

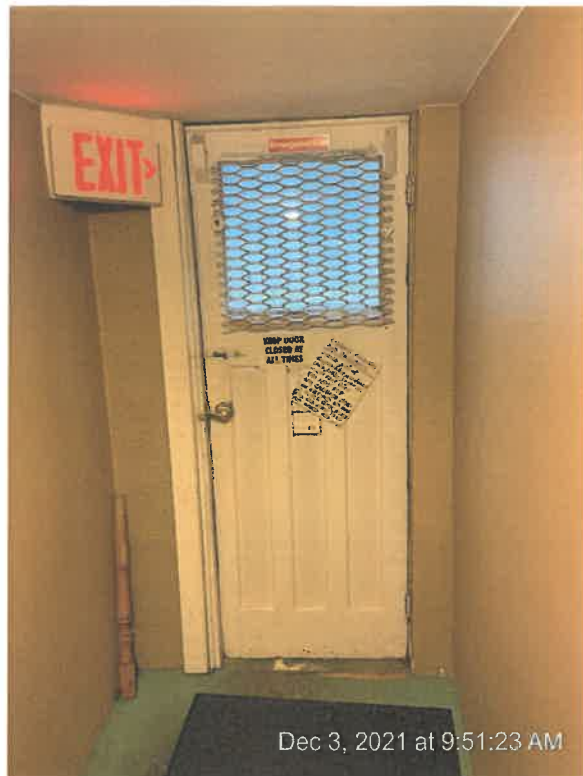
Photo 1: Lock on basement rear exit door near Laundry Room requires replacement.

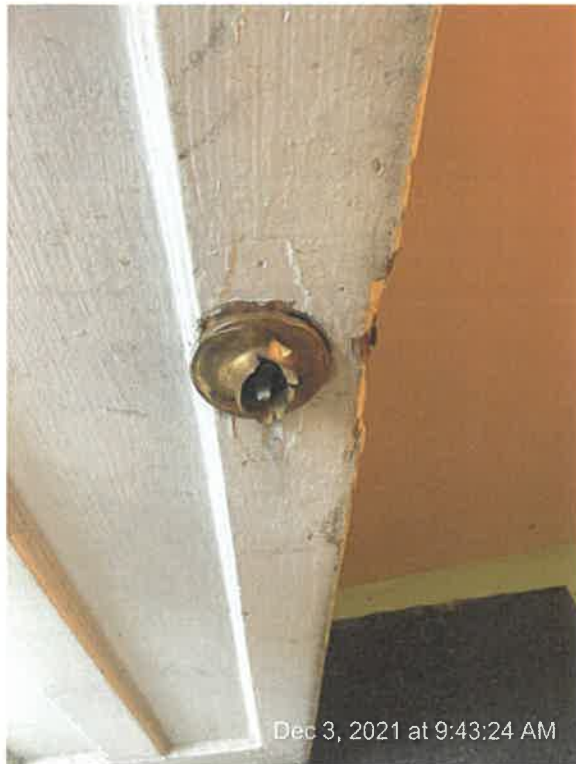
Photo 1A: Exterior lock on above-noted exit door requires replacement.

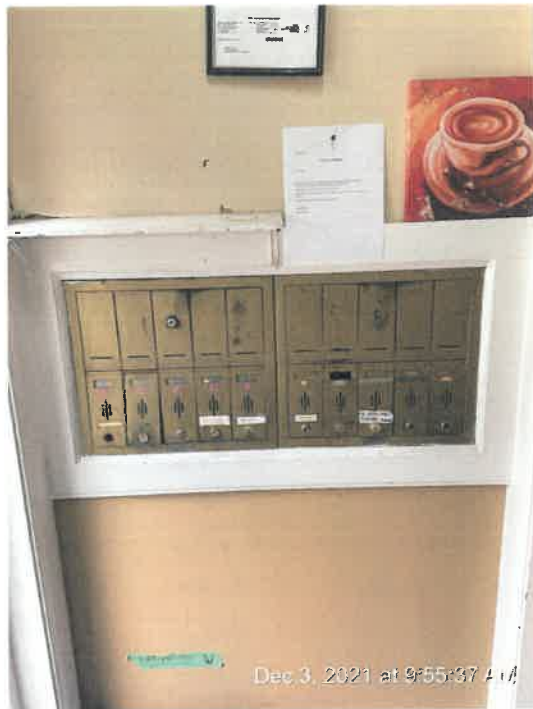
Photo 2: Mailboxes at main entrance need to be secured.

- Appliances and TV need to be removed from the common areas of the building (photo #19).
- Staircase broken window between 2nd and 3rd Floor needs to be fixed (photos #11, #12).
- Mailbox by front door are not secured and missing locks (photo #2).
- Basement exit door lock is broken and needs to be replaced (photo #1A).
- Fire assemblies must be corrected to be intact.
 - There are multiple locations in the building where drywall has been removed to access plumbing or other building services and not properly replaced (photos 24 A & B).
 - The boiler room ceiling, in particular, must be replaced with fire-rated drywall, fully taped and caulked, securely fastened to the ceiling to maintain a 1-hour fire separation. (photo #23).
- Provide a working light in the boiler room.
- Insure Owner has working keys to every unit for inspections.

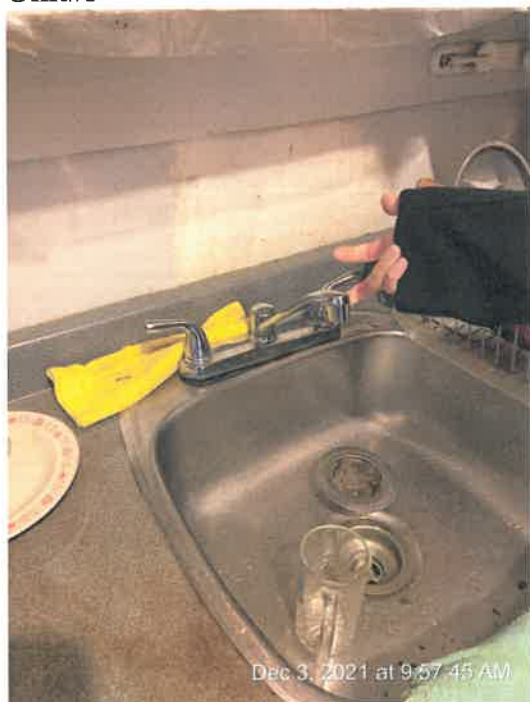
Photo 3: Kitchen faucet required to be secured.

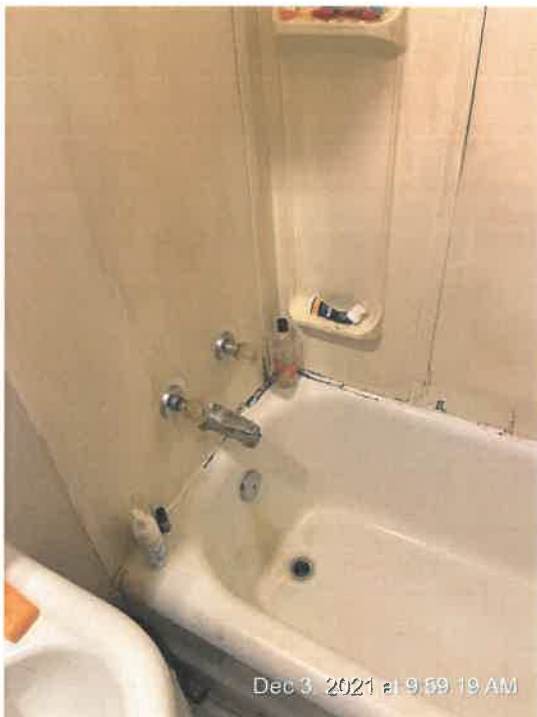
Photo 5: Tub faucet leaking and requires repair. Caulking needs to be replaced.

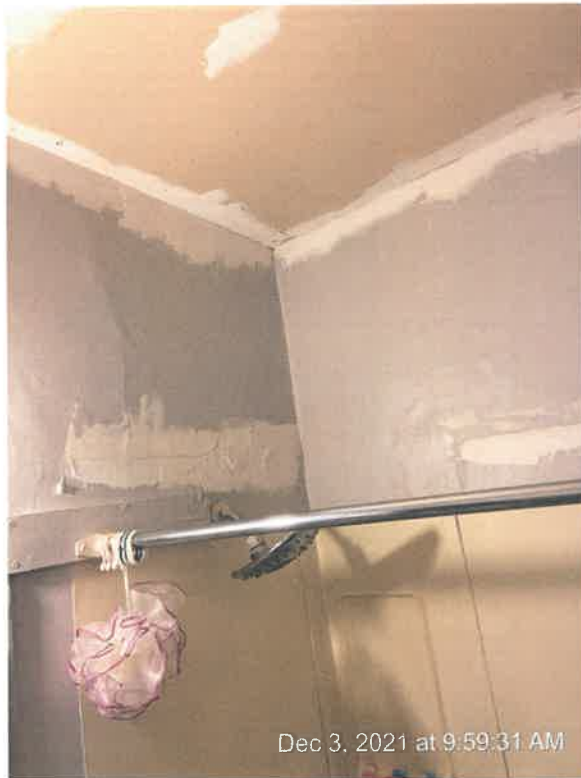
Photo 6: Washroom walls and ceiling need to be repaired and painted.

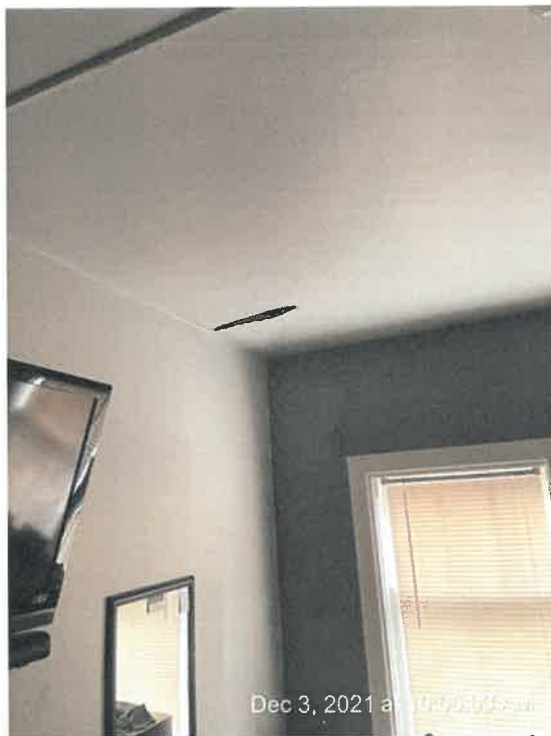
Photo 7: Roof is peeling and requires repair.

- Living room ceiling is peeling and needs to be fixed (photos #7, #7A)

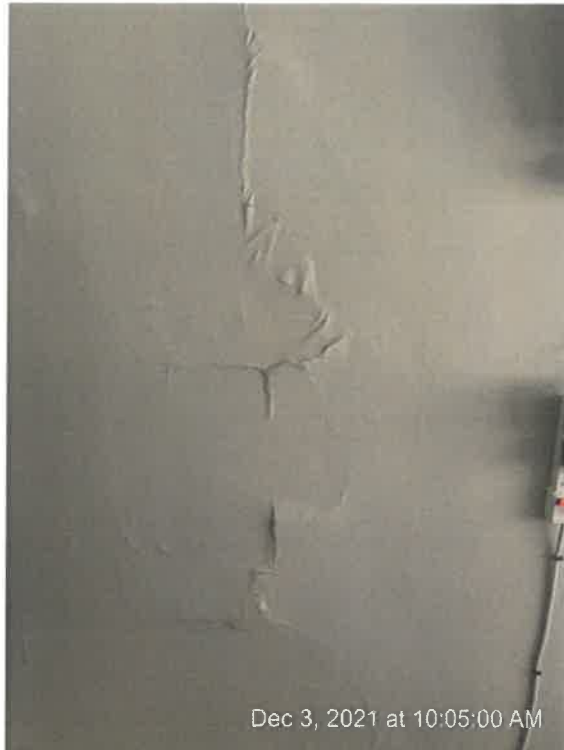
Photo 7A: Wall paint peeling and requires repair.

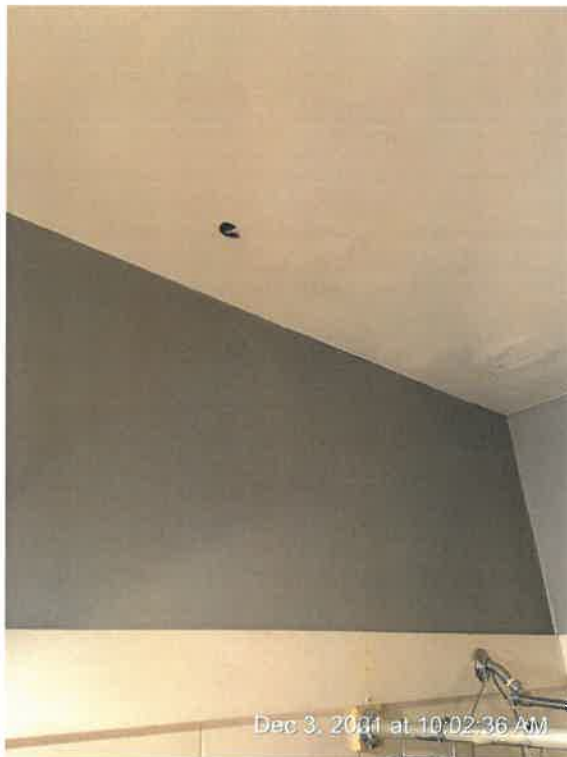
Photo 8: Hole in the washroom ceiling needs to be sealed.

- A hole in the bathroom ceiling needs to be fixed (photo #8).
- Bedroom ceiling and wall is peeling and needs to be fixed (photo #9).
- Hallway closet door knob is missing. Replace or disable hardware so someone can't get trapped in the closet.

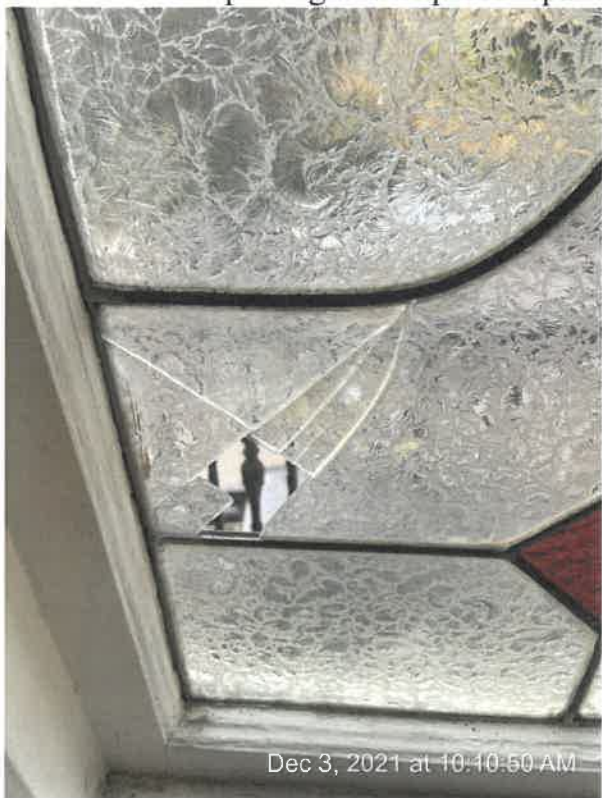
Photo 11: Close up of the broken window referred to below.

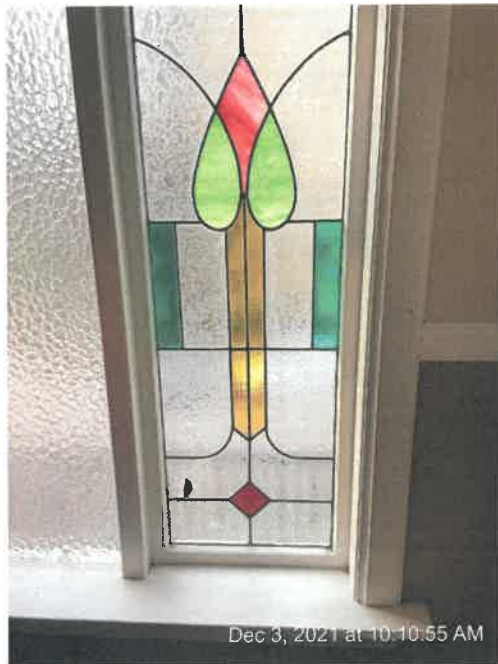
Photo 12: Broken window in staircase between 2nd and 3rd floor requires repair to prevent water and pests from entering.

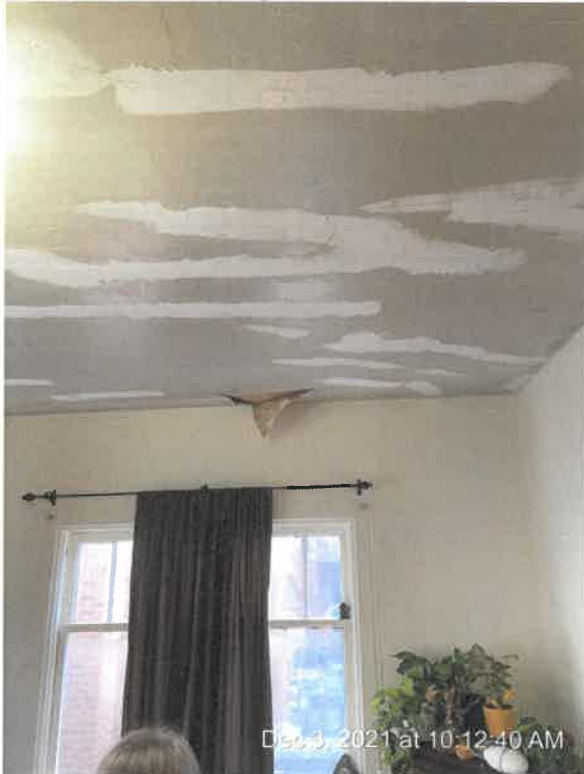
Photo 15: Ceiling is peeling and requires repair and to be painted.

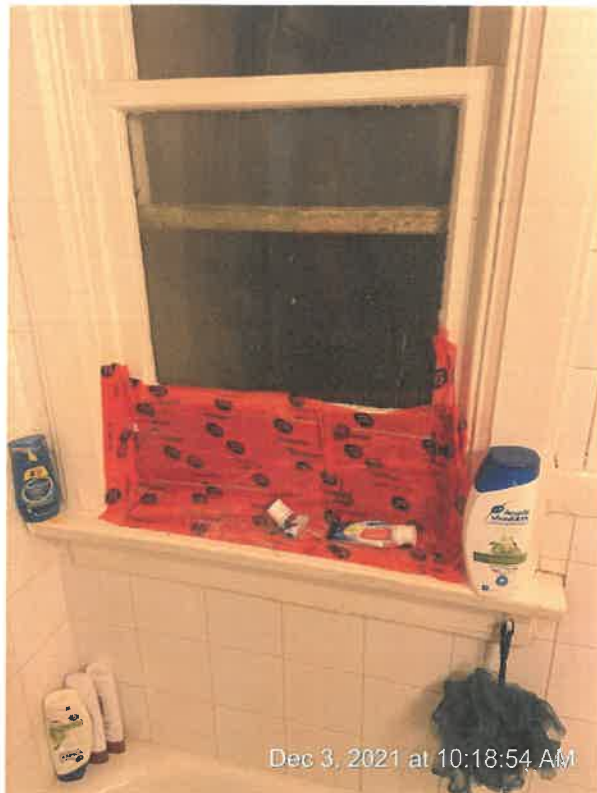
Photo 18: Washroom window requires repair.

- Washroom tap missing and needs to be fixed (photo #17).
- Washroom well window has red tape and needs repair (photo #18).
 - The light well appears to be closed and isn't offering light and ventilation as it was designed to do. Investigate condition of light well. It appears possible that the light well has been roofed over which would create a potential for mold within the light well and that would be detrimental to the health of the occupants.

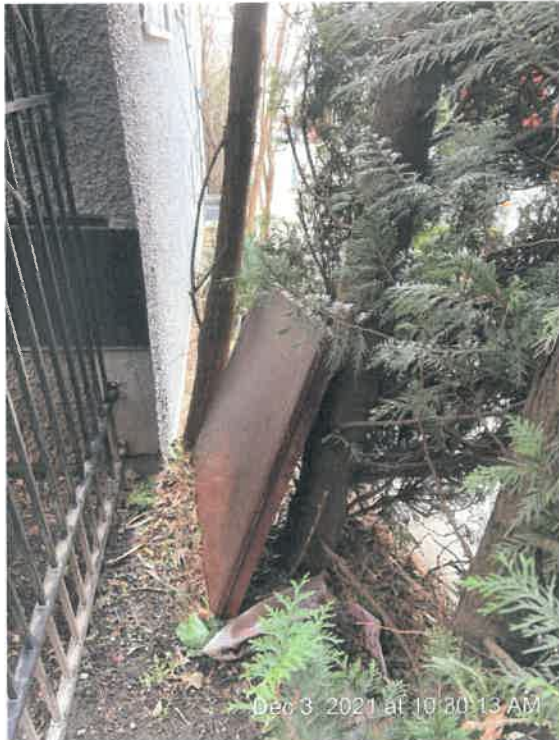
Photo 20: Table behind front hedge towards 4th Street needs to be removed.

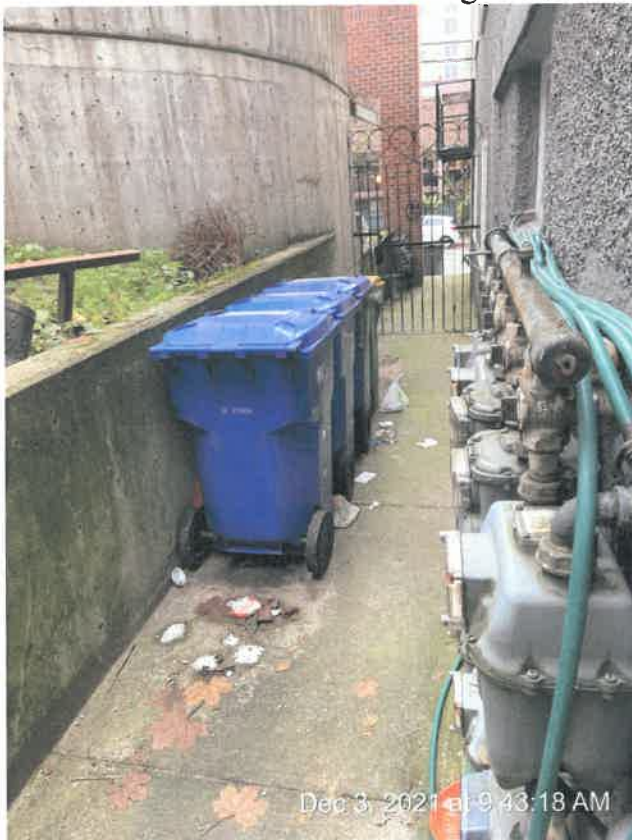
Photo 21: Rubbish around the garbage containers needs to be removed.

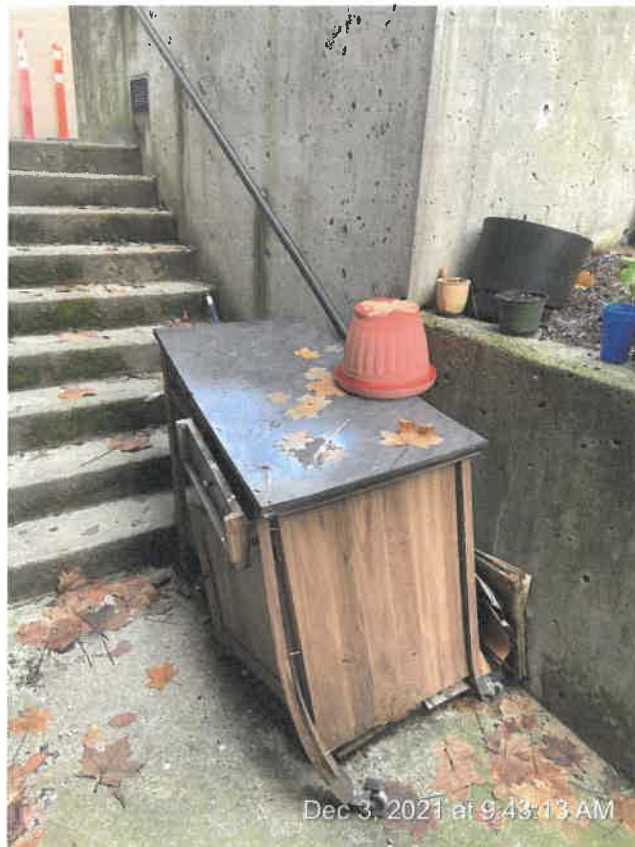
Photo 22: Desk needs to be removed from the back area of the building.

- An old desk in the back sidewalk of the building that needs to be removed and taken to a proper disposal facility (photo #22).
- A table by the north-west wall of the building behind a hedge towards Fourth Street needs to be removed (photo #20).
- The building exterior facing Carnarvon, appears to be sliding west and south down the hill. The exterior wall is bowed and the windows are racked shut. Provide a structural report confirming that there is no concern for imminent collapse and make recommendations for stabilizing the building. The letter shall make specific reference to the continued habitability of Units 1 and 2 and confirm if any shoring is required.

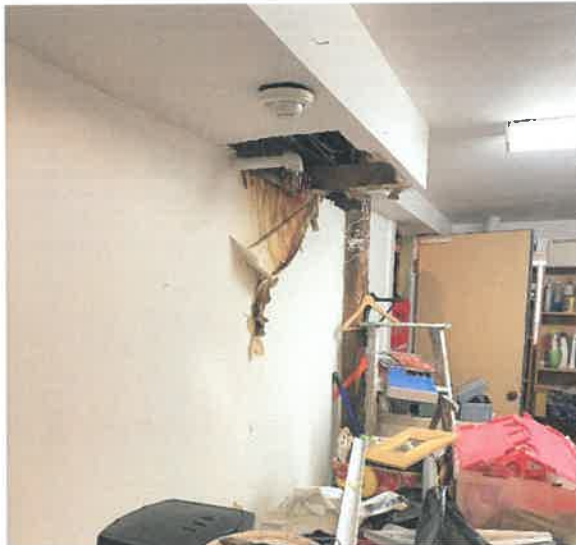
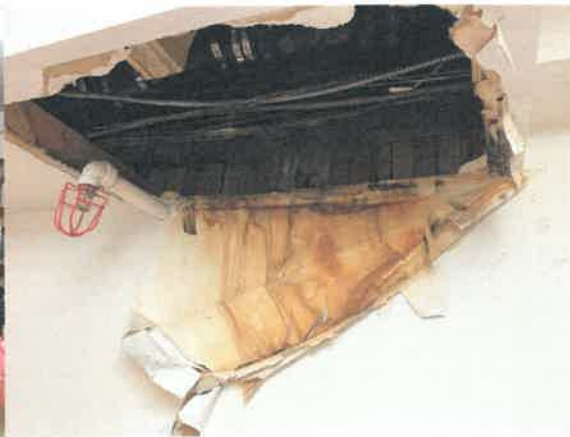
Photo 24A & 24B: Storage room outside of Boiler room – repair fire separation (one example of several breaches in the fire assemblies in the common areas)
