Attachment E

349 Cumberland st

349 AND 351 CUMBERLAND ST

ENGINEERING PROPERTY / BUILDING CONDITION ASSESSMENT

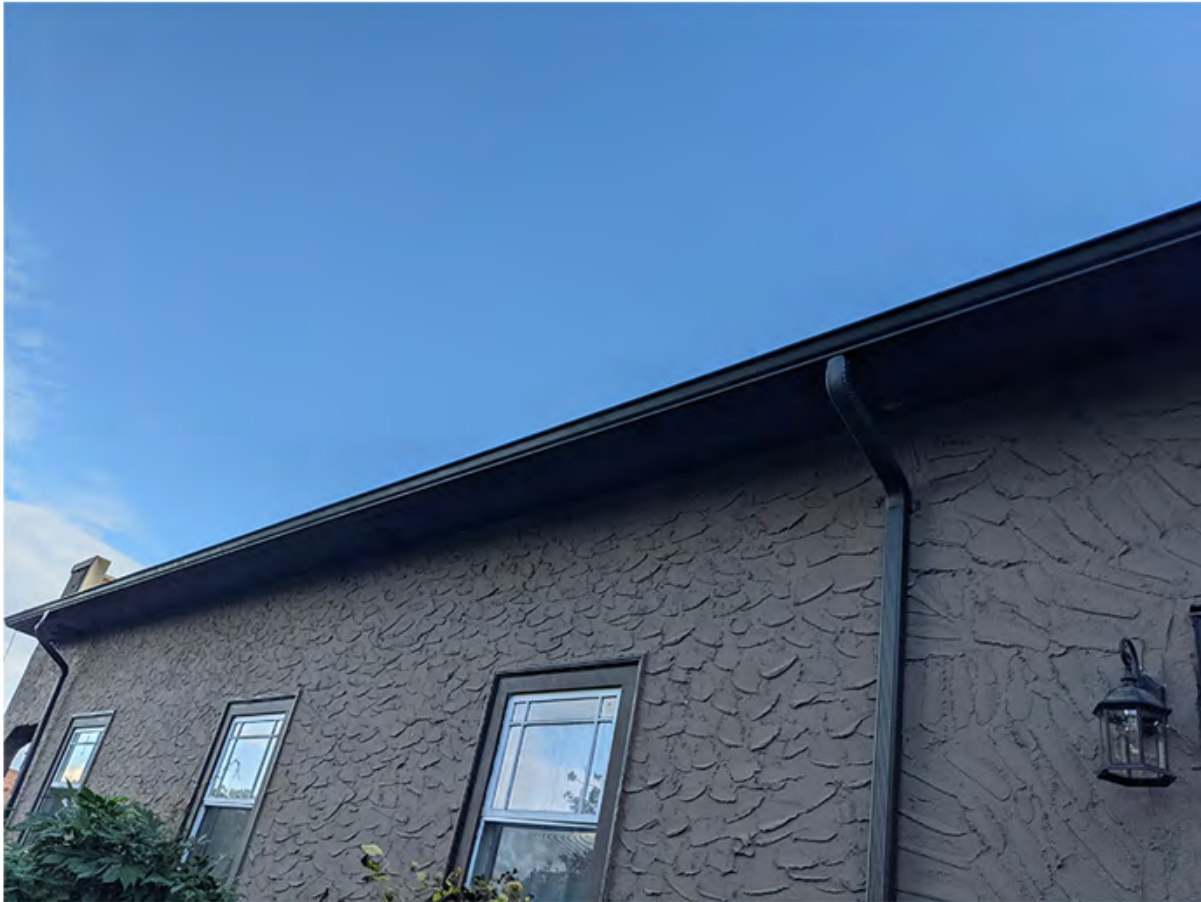
north wall eavestrough downspouts.jpg

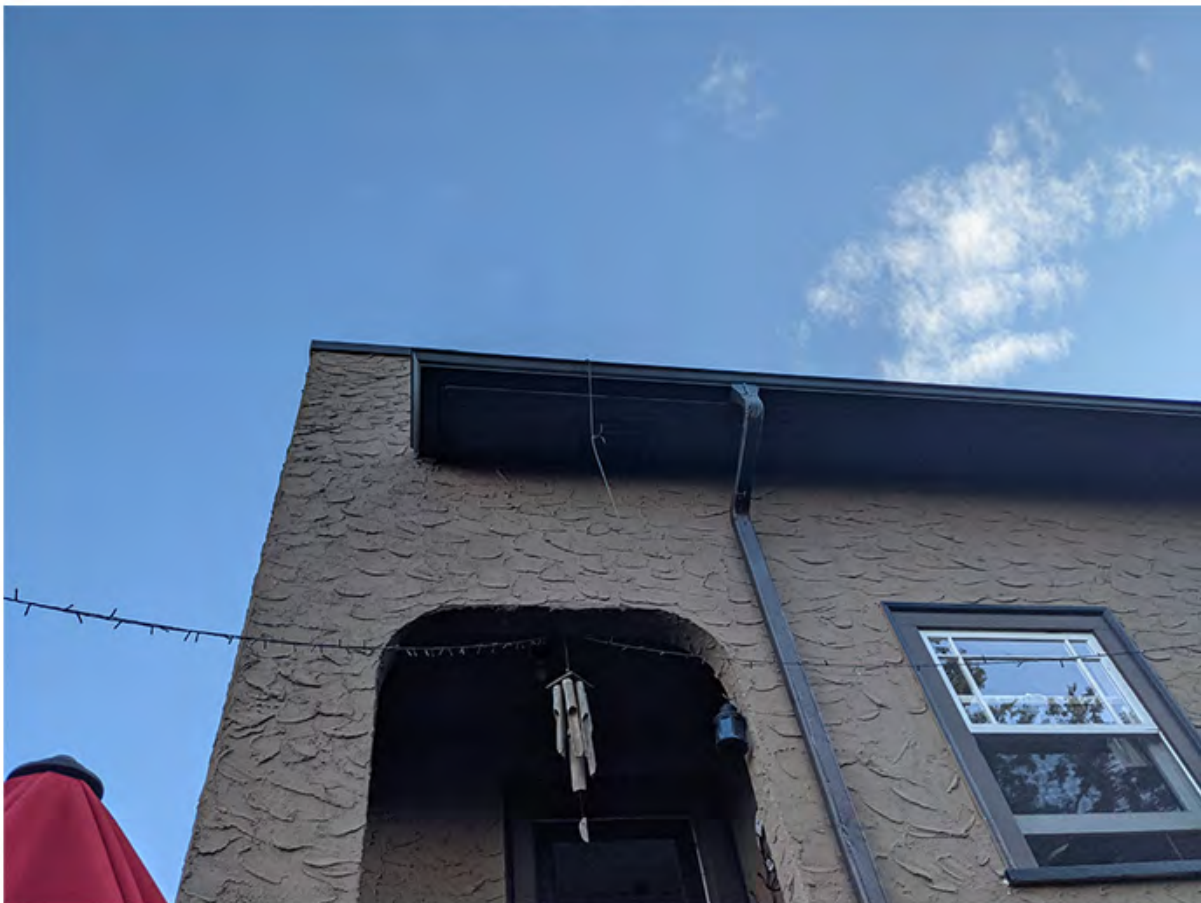
unit 349 - eavestrough downspout on north wall east side.jpg

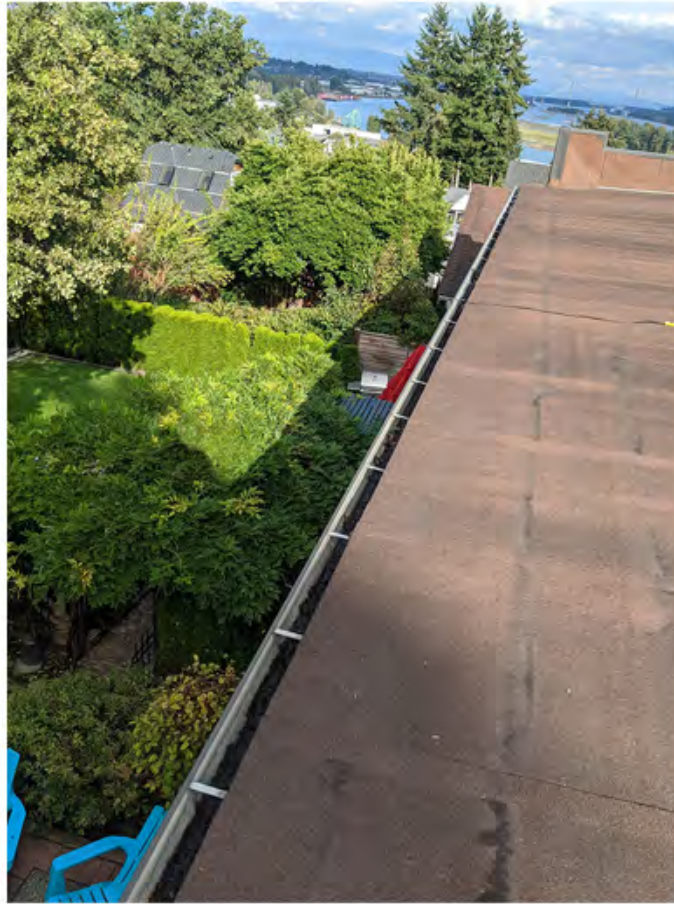
view looking east along north eavestrough.jpg

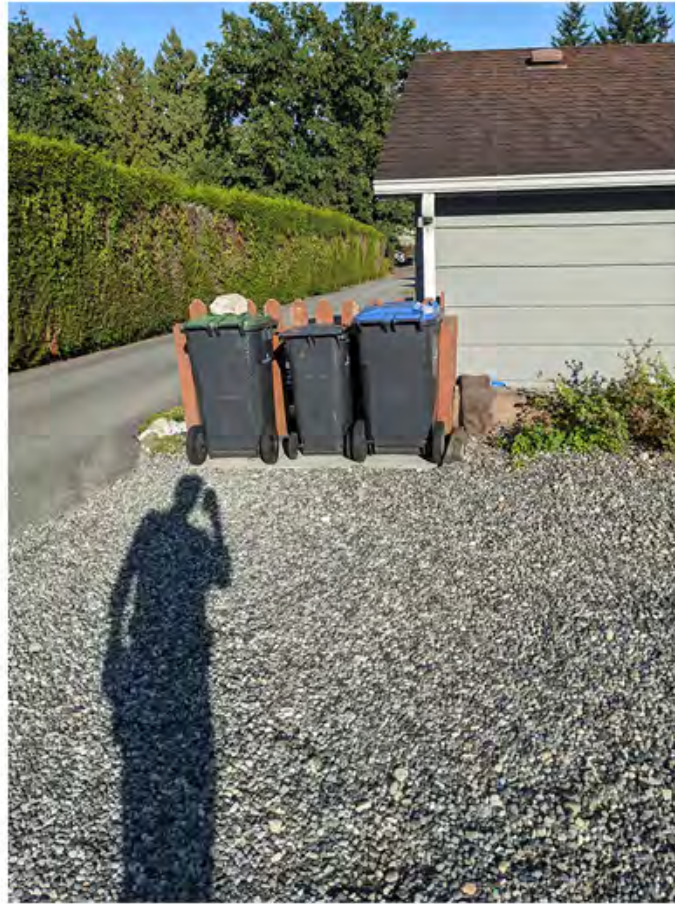
unit 349 - concrete pad for refuse bins.jpg

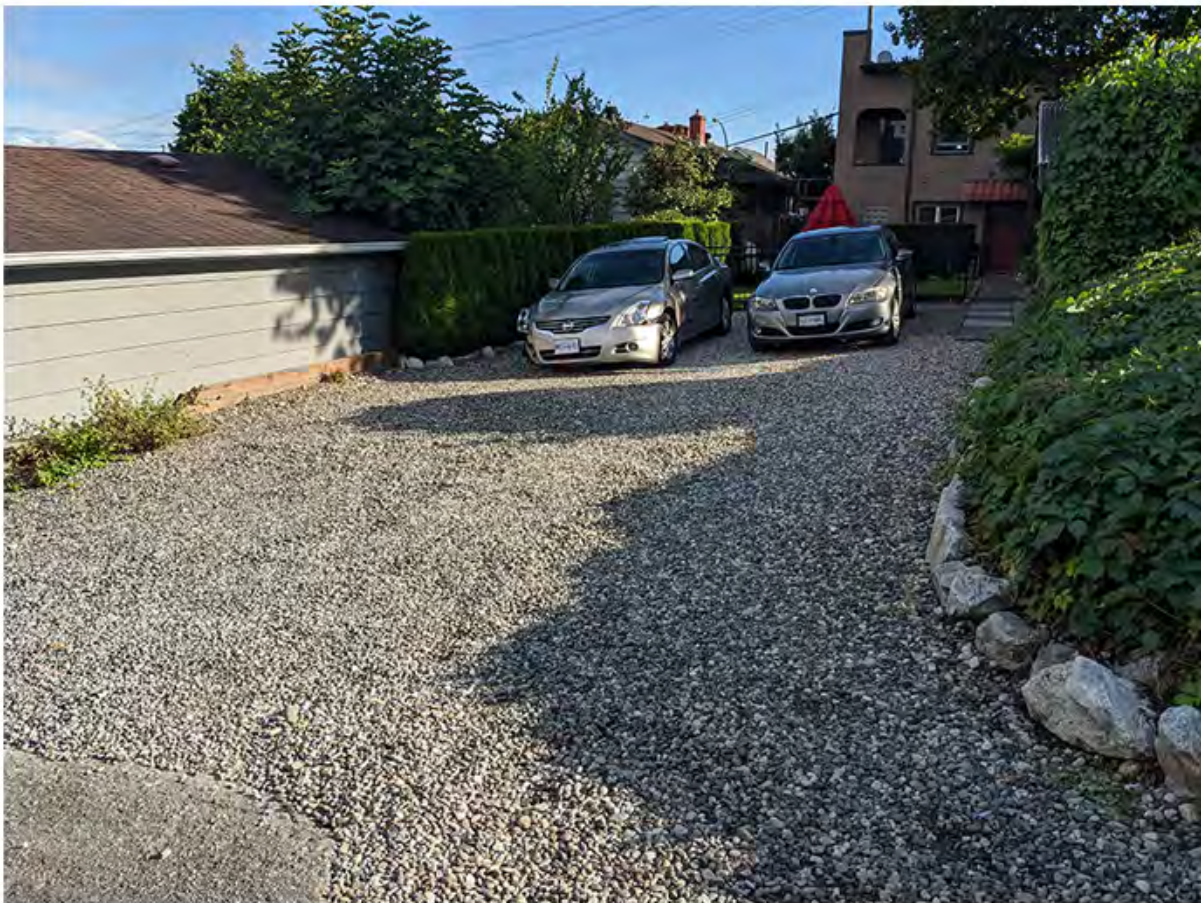
unit 349 - gravel parking pad.jpg

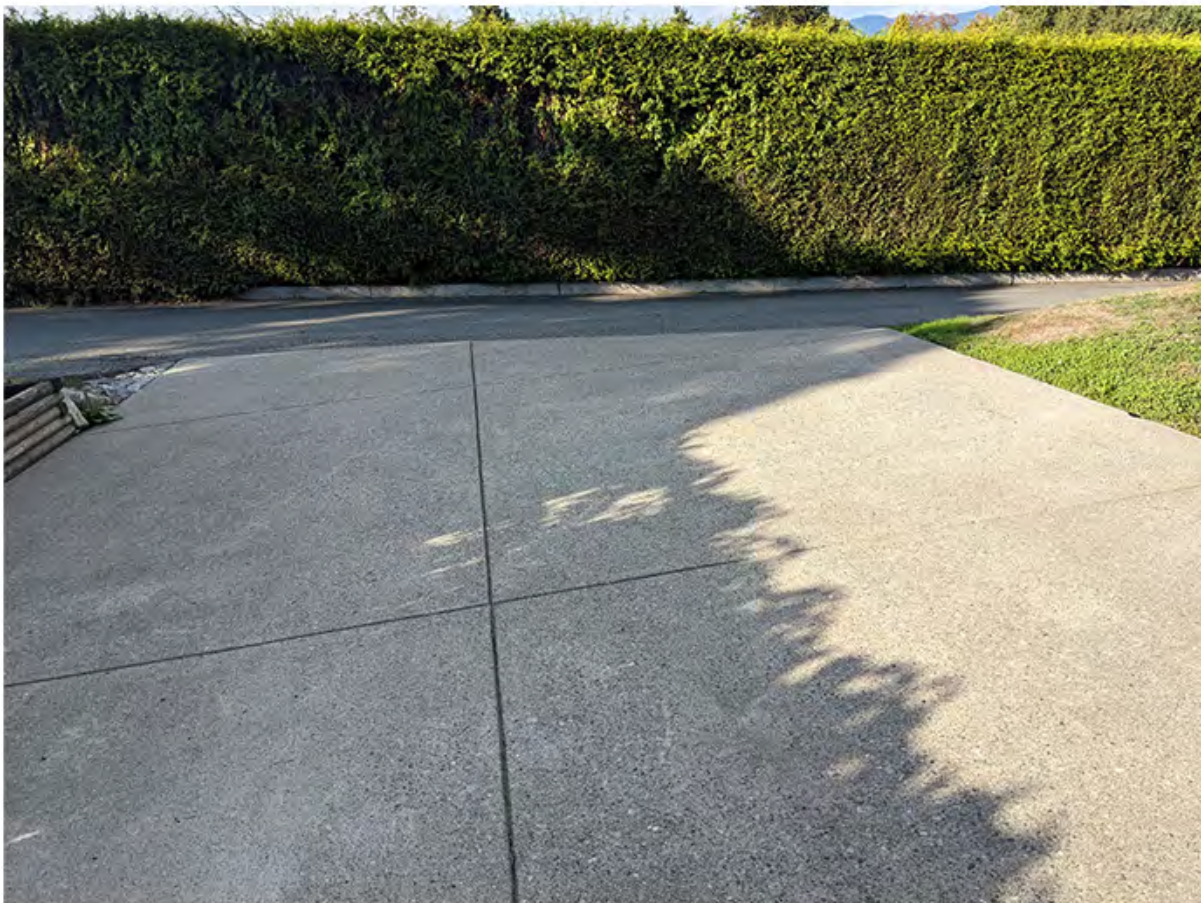
unit 351 - concrete parking pad on north side.jpg

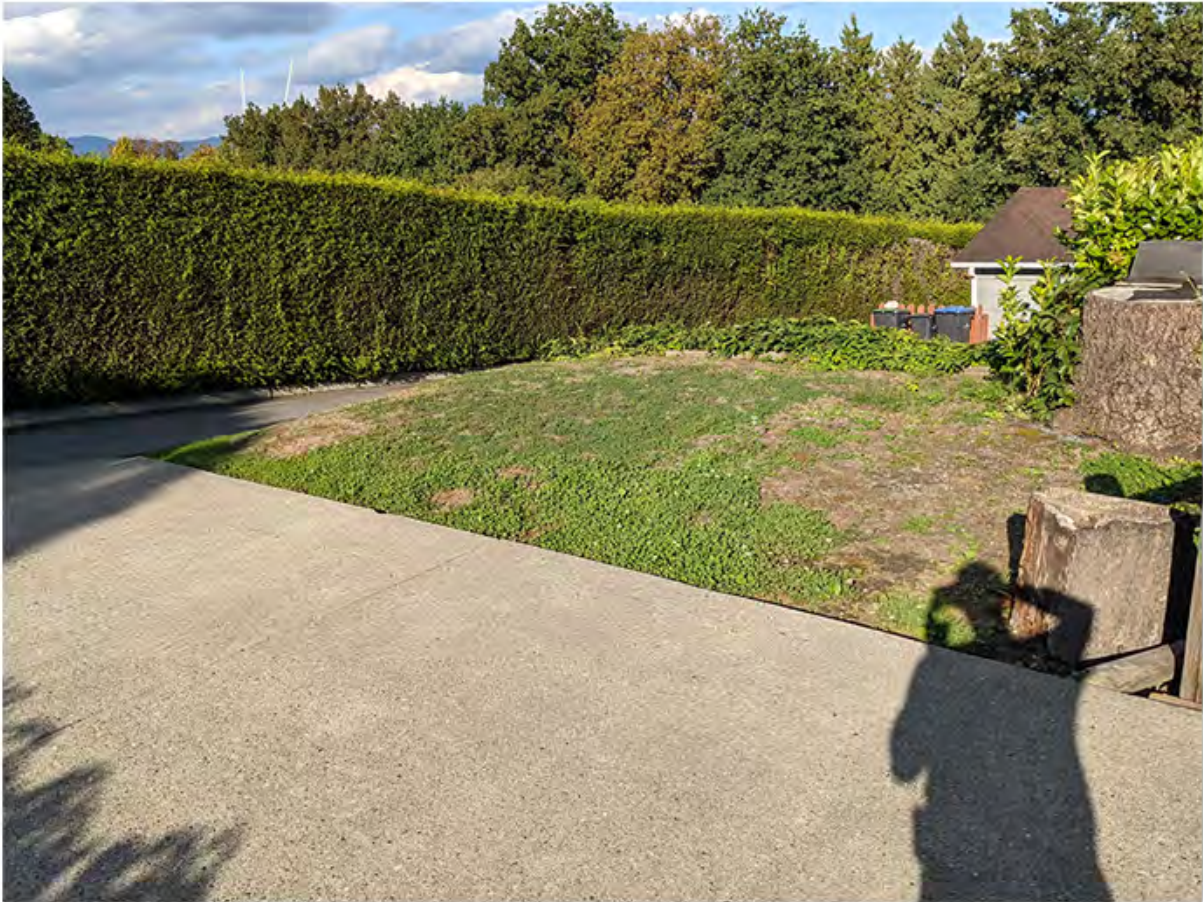
unit 351 - view looking north-east from parking pad.jpg

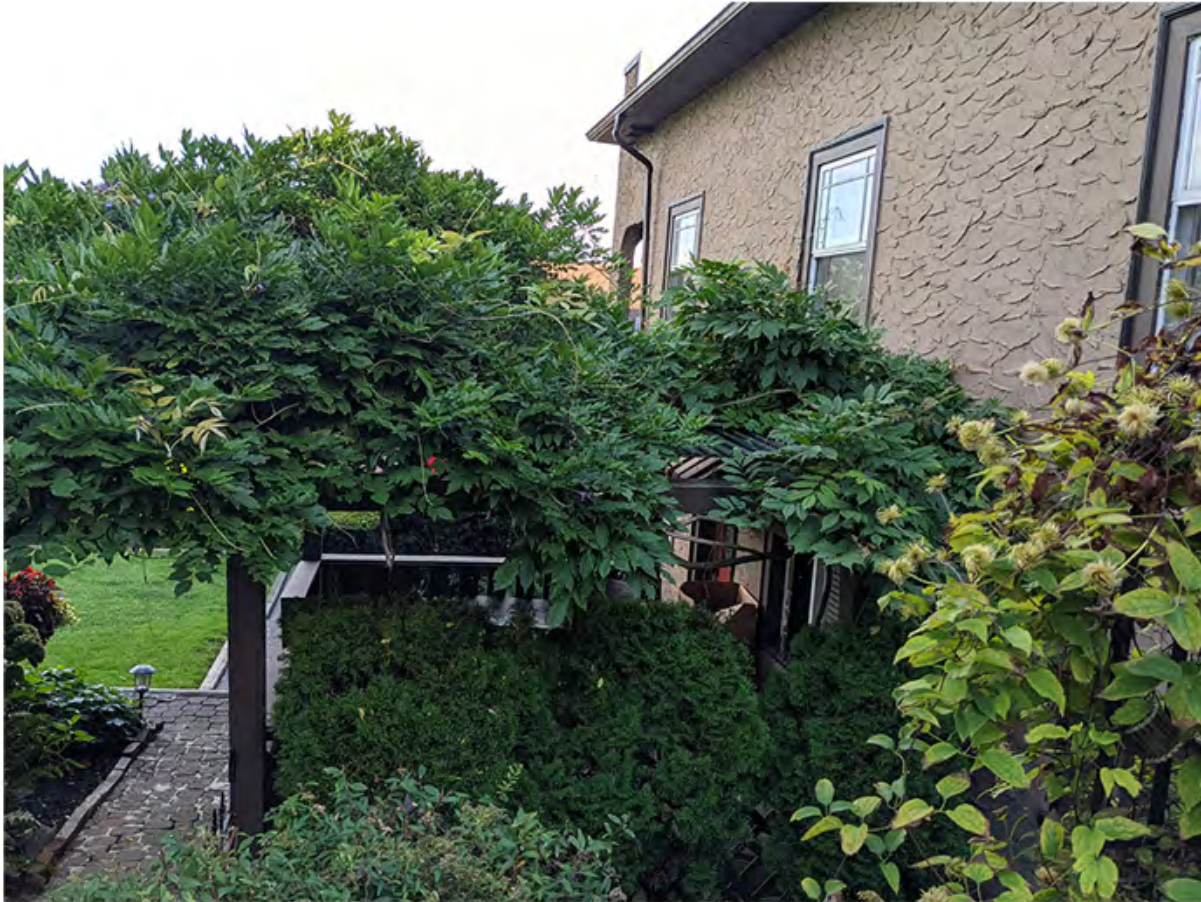
unit 349 - pergola north of Subject Building.jpg

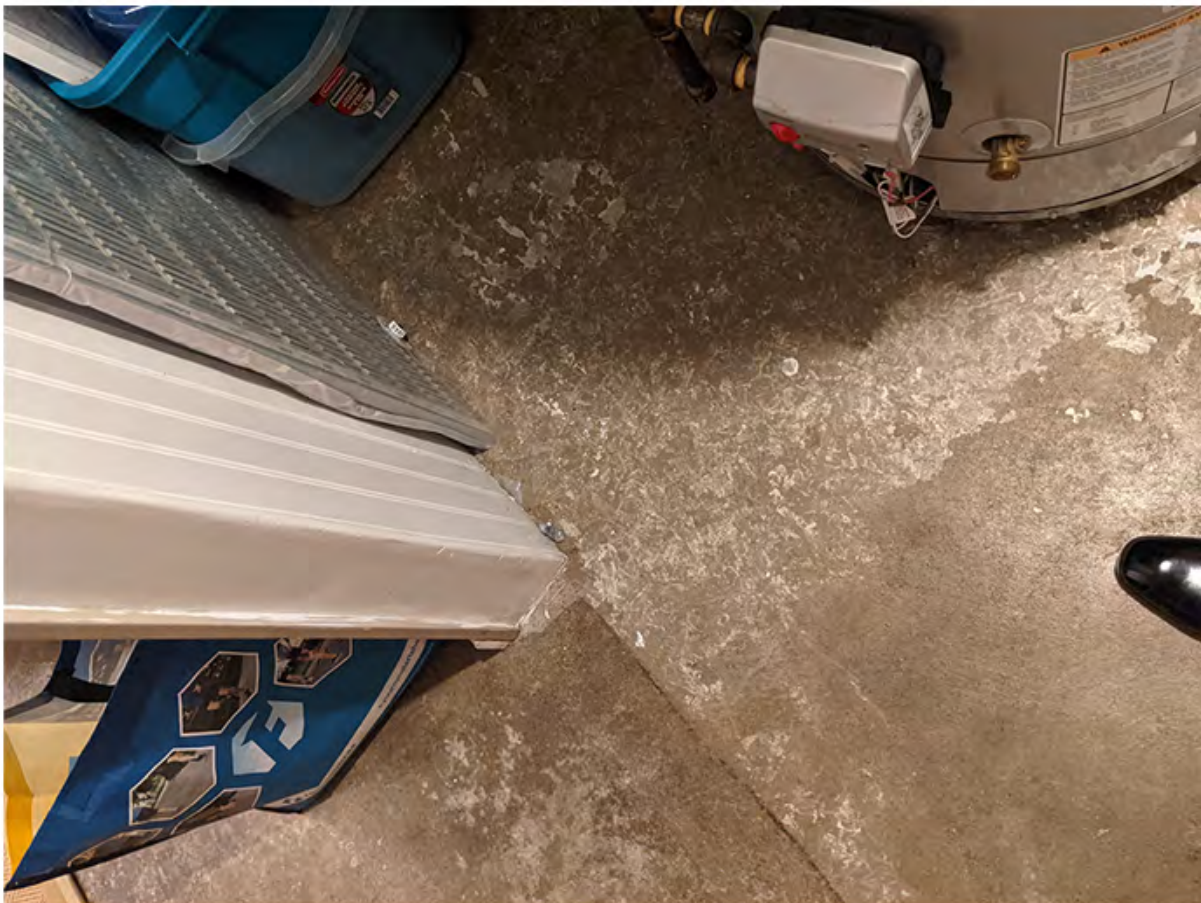
unit 351 - concrete floorslab in lower level.jpg

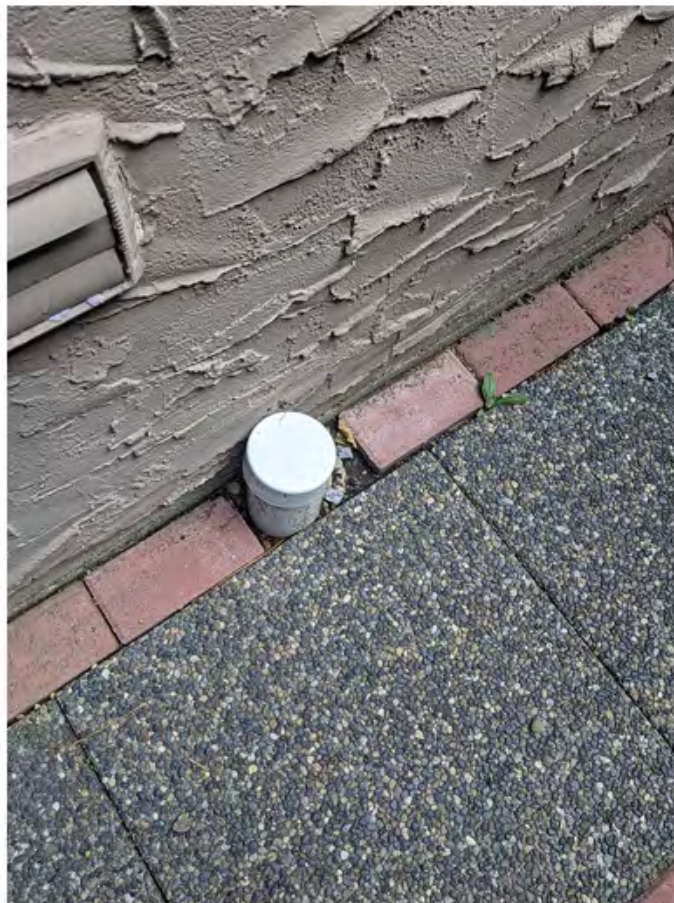
unit 351 - weeping tile clean-out on west outer wall.jpg

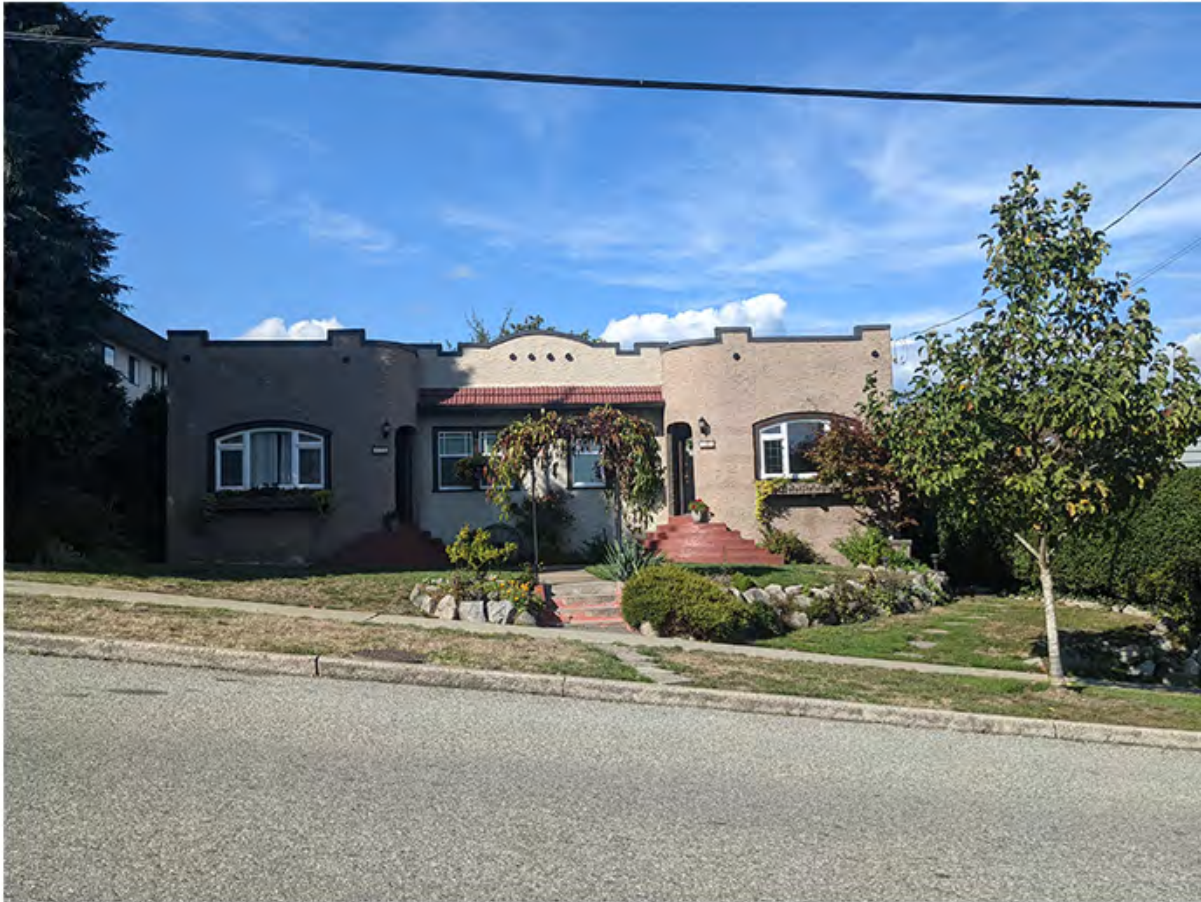
south wall.jpg

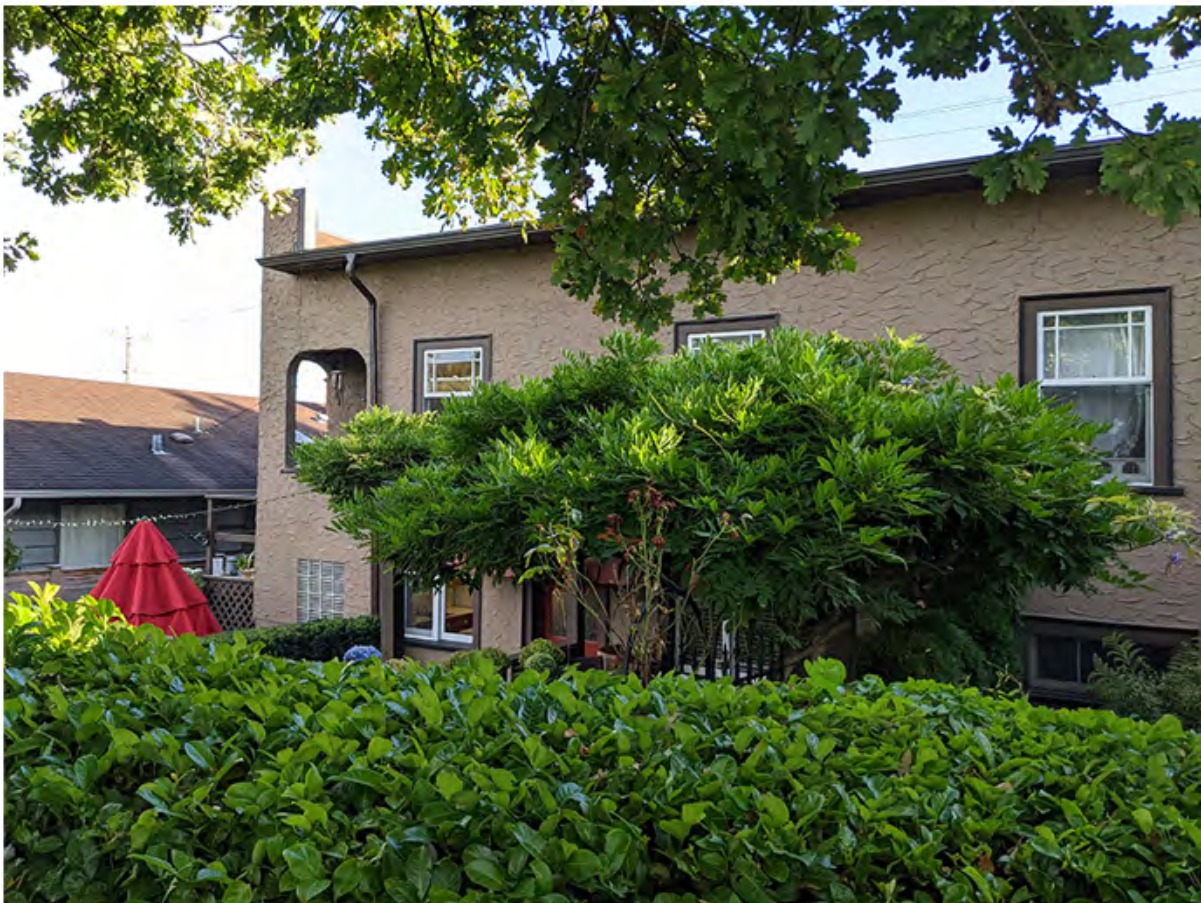
unit 349 - north wall.jpg

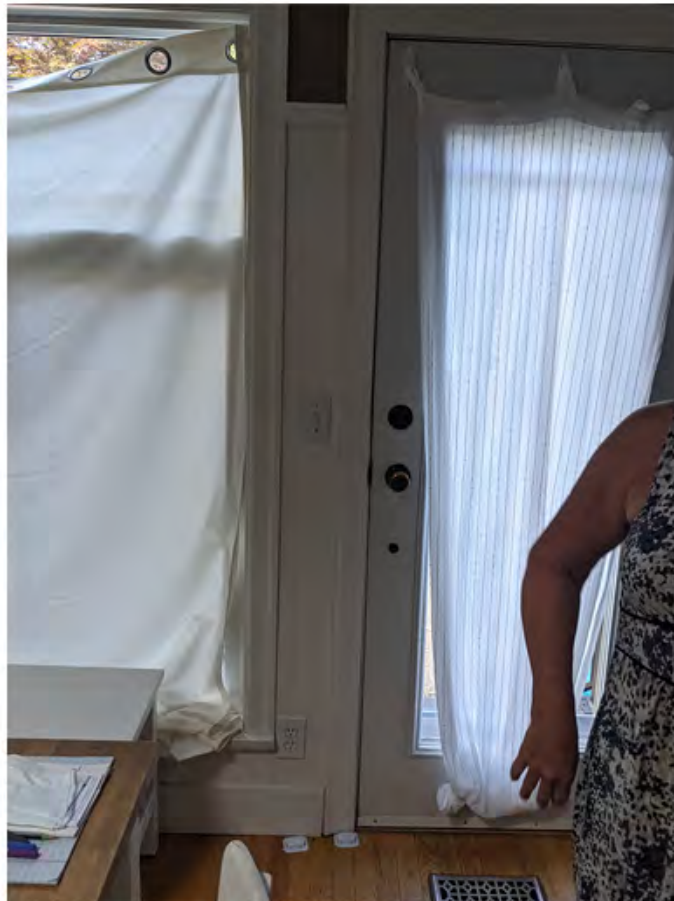
unit 351 - north entryway door.jpg

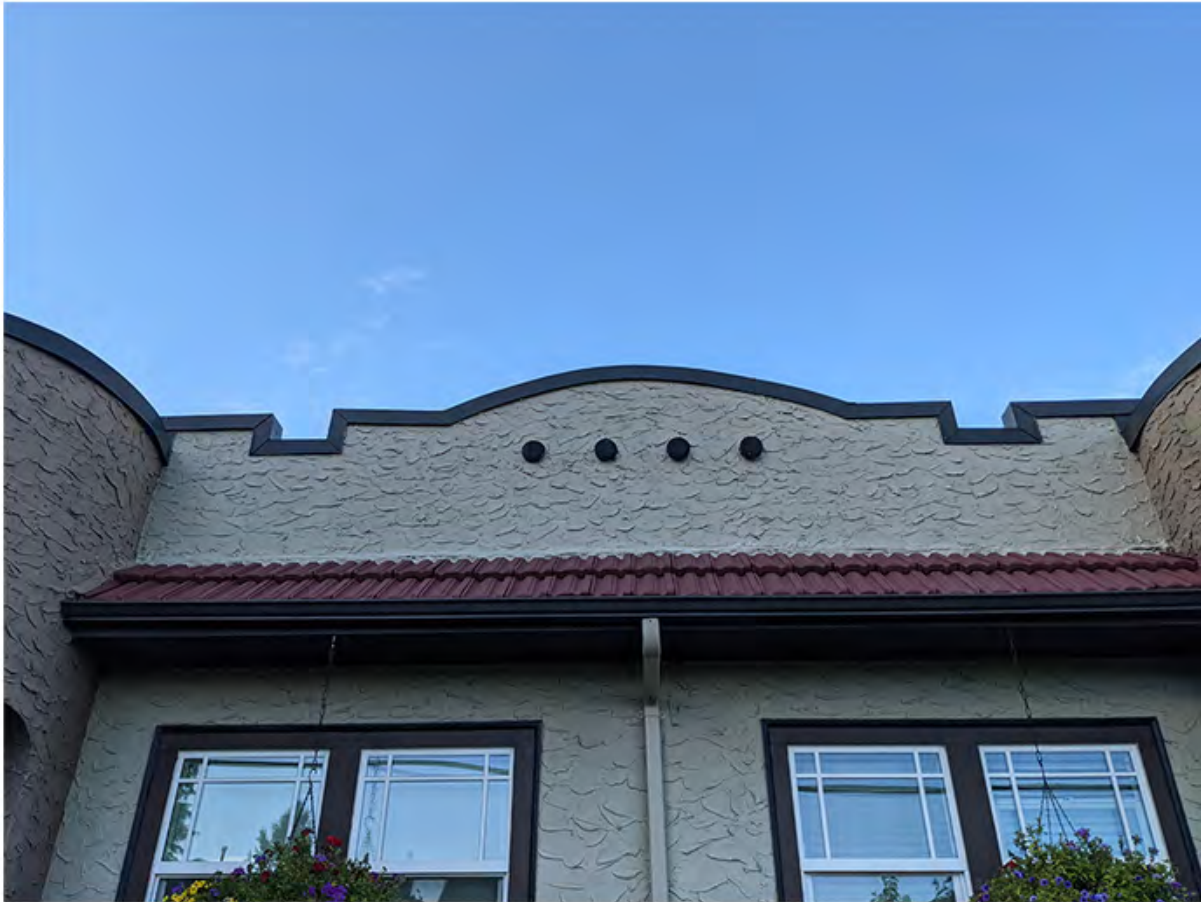
attic venting on south side.jpg

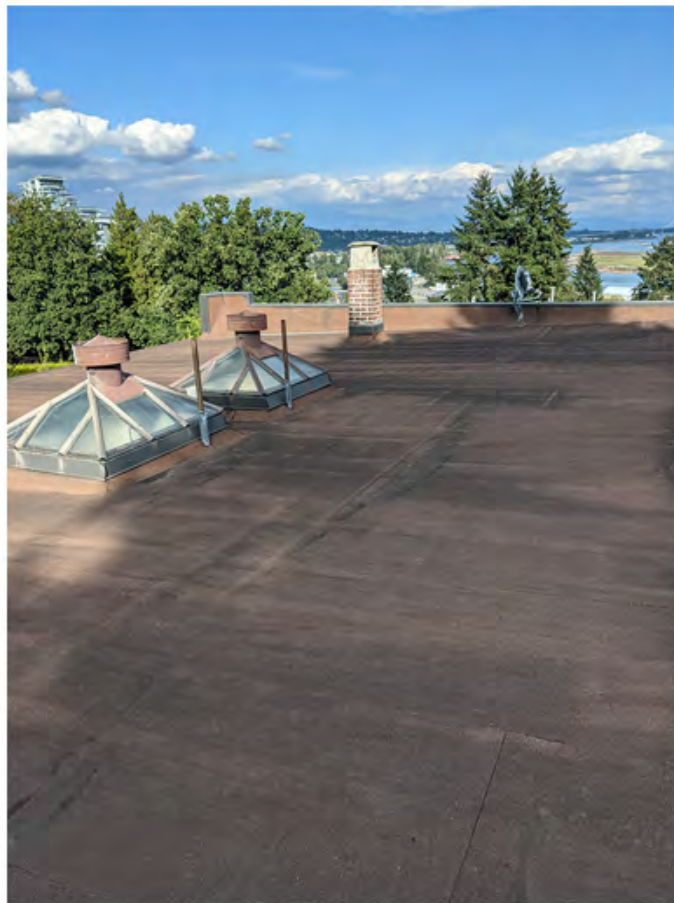
WC skylights for both units.jpg

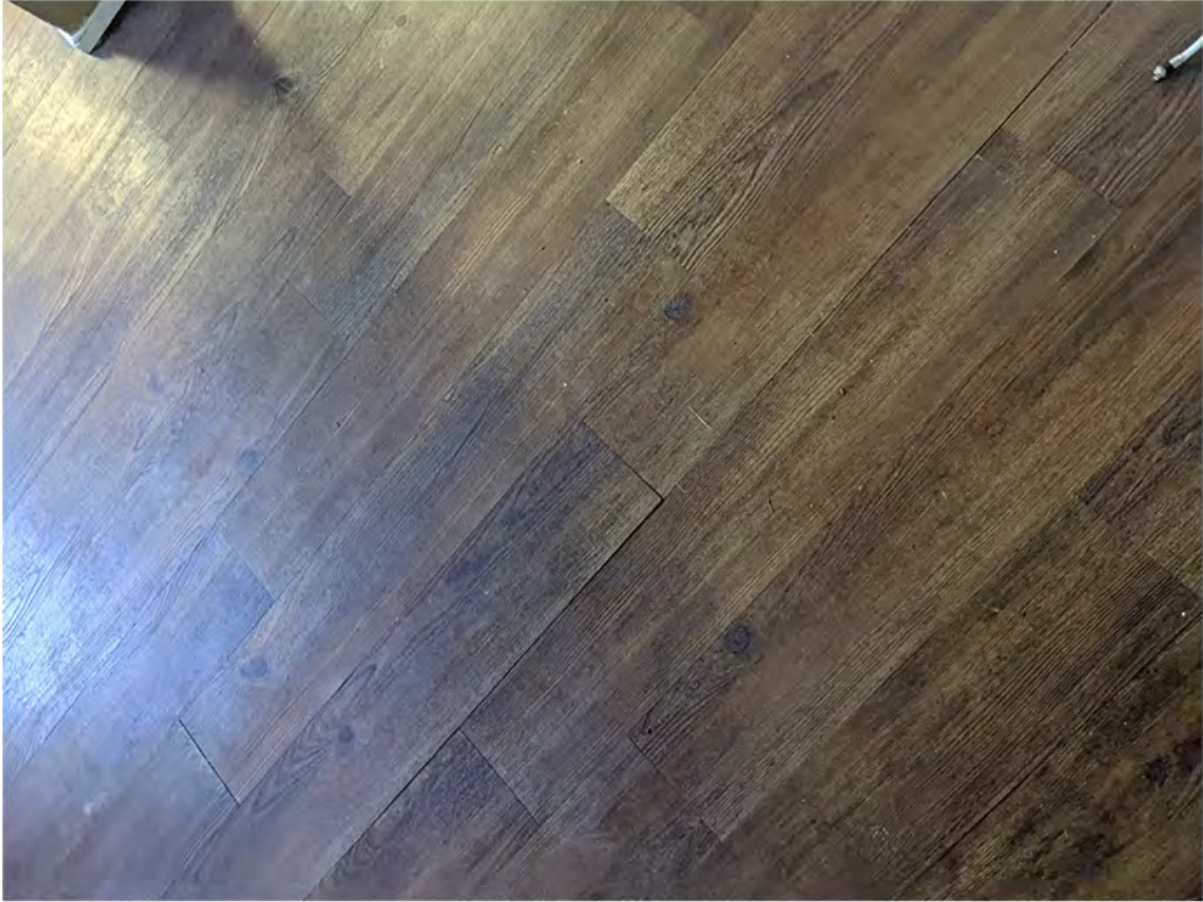
unit 349 - lower level flooring.jpg

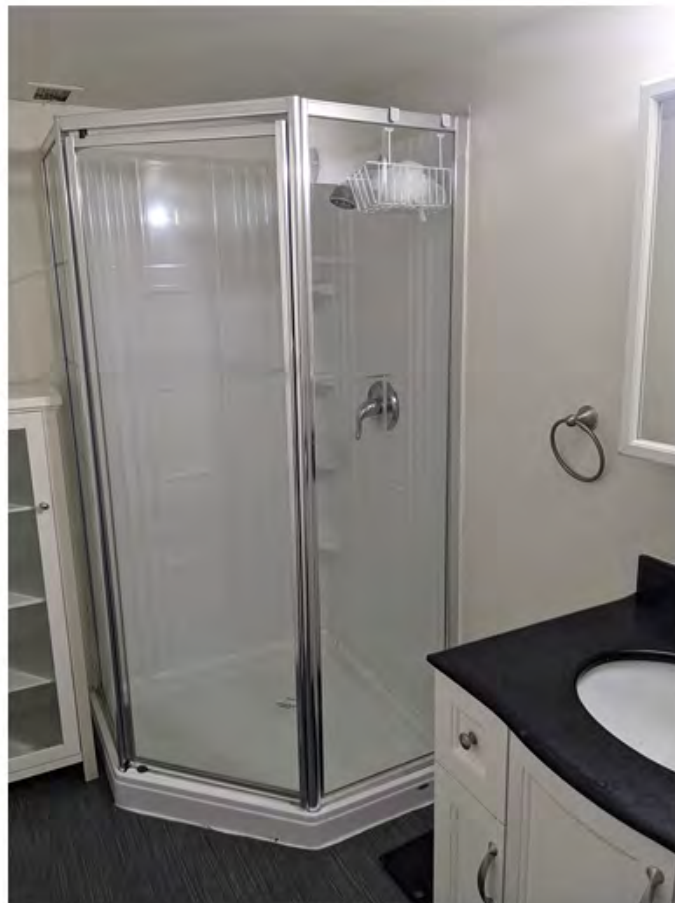
unit 349 - lower level WC finishings.jpg

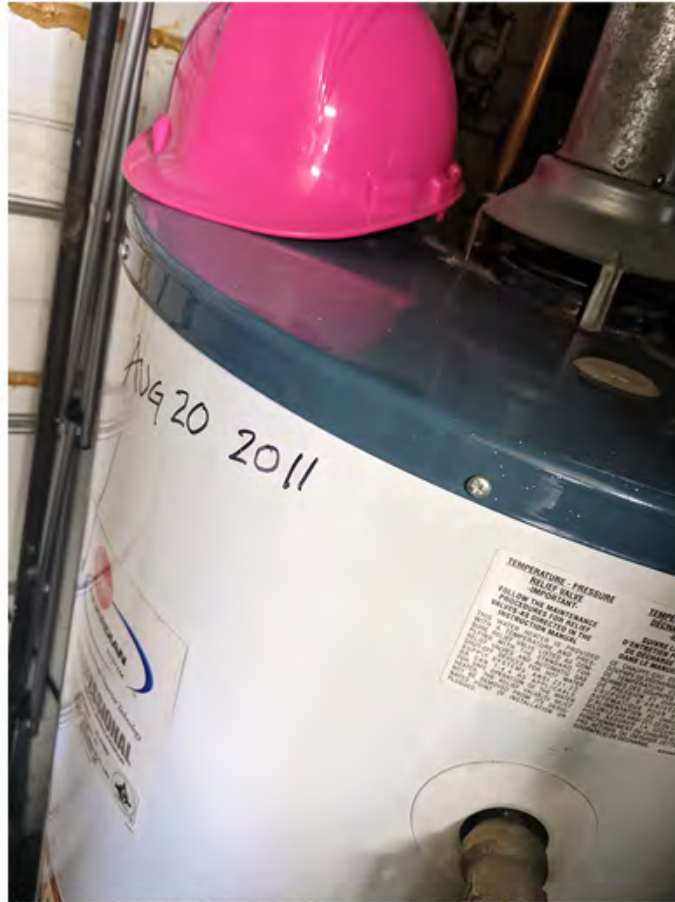
unit 349 - water heater installed in 2011.jpg

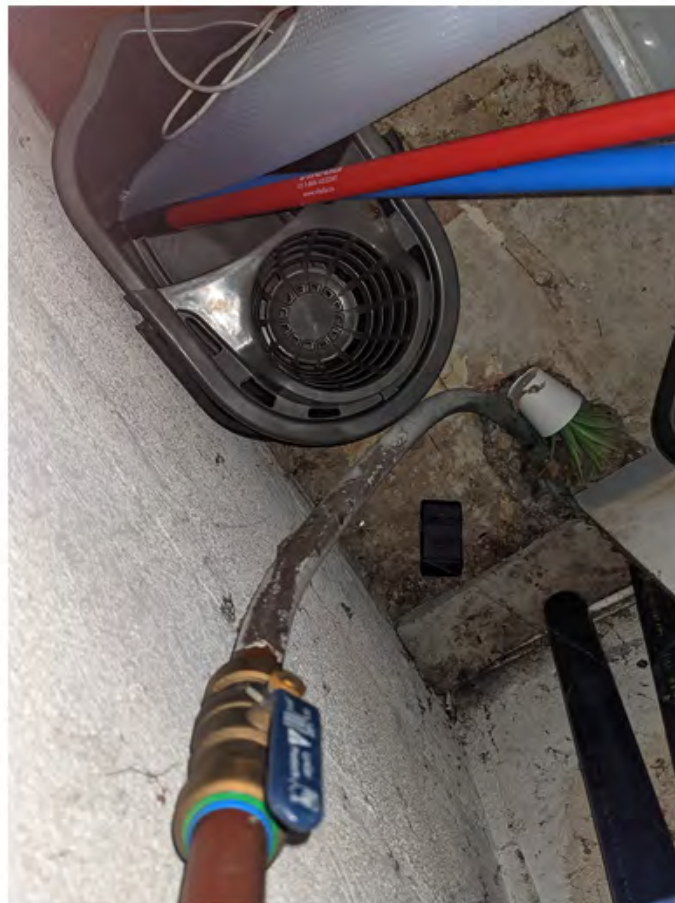
unit 349 - water supply to Subject Building with no meter and potential lead piping.jpg

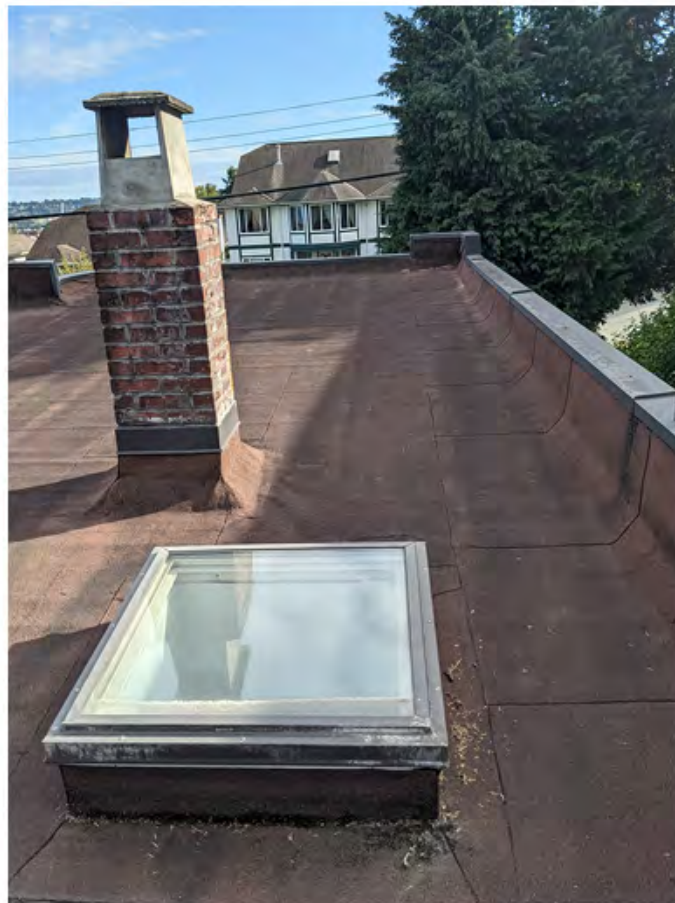
unit 351 kitchen skylight and chimney.jpg

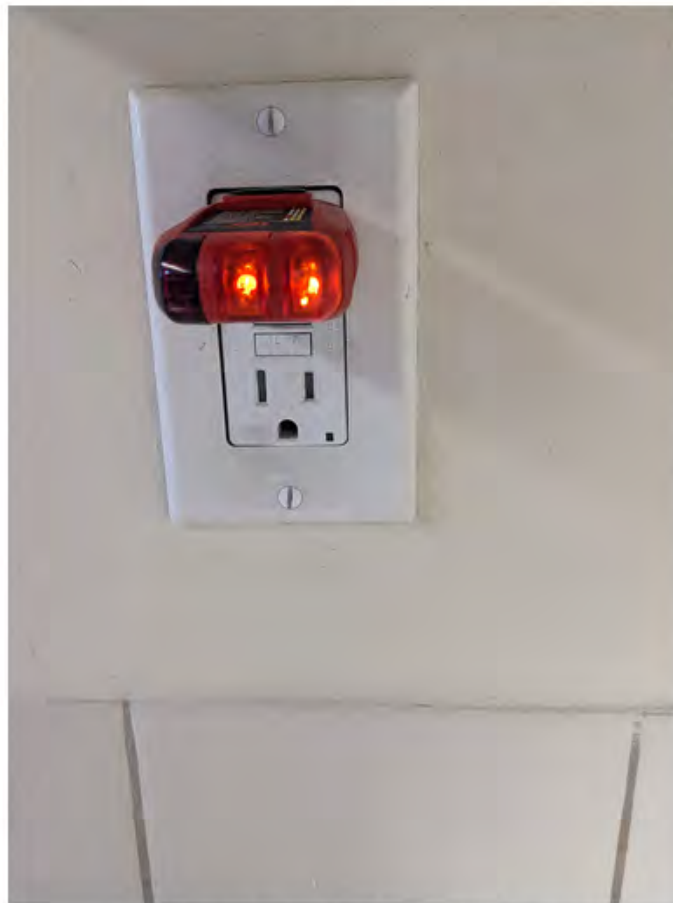
CMG performed random electrical tests on the 110V outlets in the Subject Building, and saw no evidence of any defects. The Client indicated that an electrician came in and replaced all the original electrical wiring, and the new system should have a lifespan of approximately another 50 years.

unit 349 - one of several random electrical tests.jpg

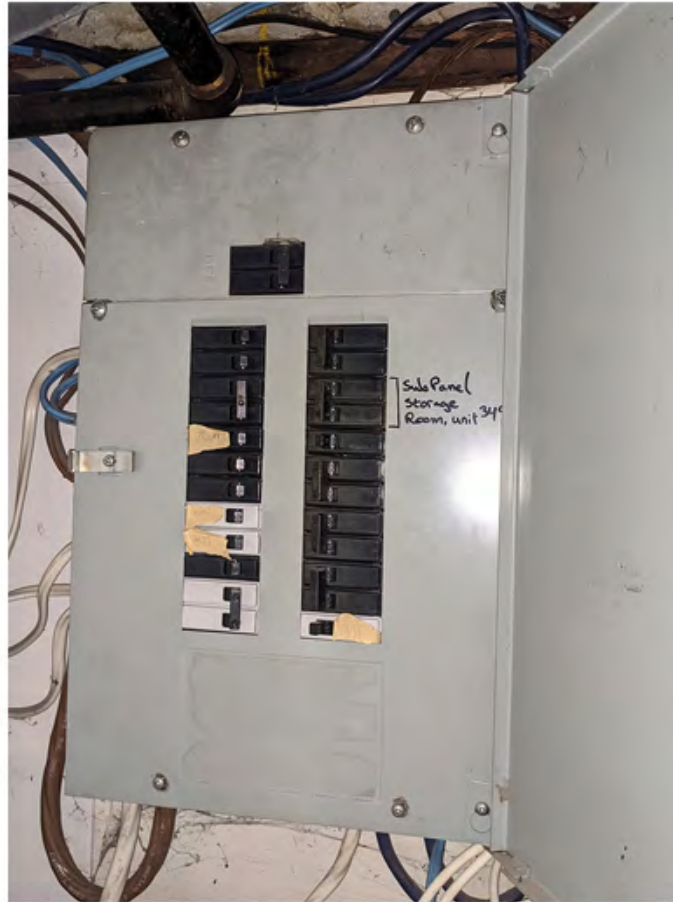
unit 349 - 100Amp electrical panel in lower level on east wall - south side.jpg
